**B.M.C. SERVICE LTD.  
COWLEY, OXFORD**

# INDEX TO

## IMPROVEMENTS AND ALTERATIONS

**AUSTIN SEVEN**

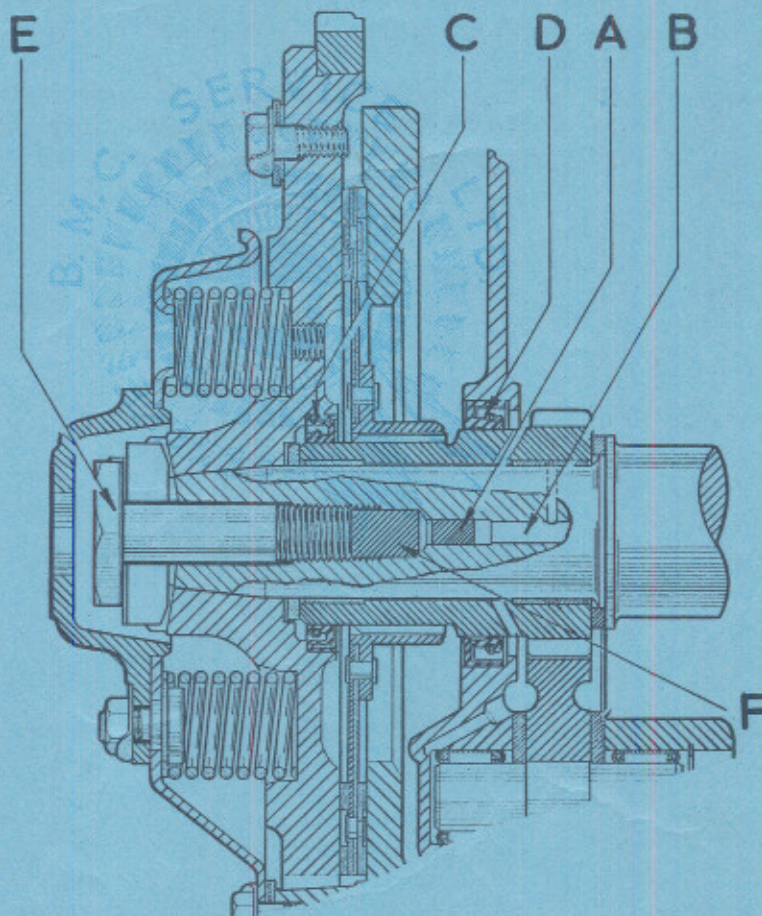
## OIL LEAKAGE INTO CLUTCH

There are three possible causes:

- (1) leakage past brass plug 'A' at end of oilway 'B'
- (2) leakage past seal 'C'
- (3) leakage past seal 'D'.

To check for (1), withdraw flywheel retaining screw 'E'. If this is quite dry, the brass plug 'A' is not suspect and dismantling should proceed in order that seals 'C' and 'D' may be examined. Leakage here would most likely be due to damage in assembly and new parts should be fitted as necessary.

If, on the other hand, oil leakage is in evidence at (1), this may be due to the fact that the rubber plug 'F' (Part No. 22A64) - which is an added precaution against leakage at the brass plug 'A' - is not in contact with the tip of the retaining screw 'E', as intended, and has therefore not been 'spread' and is failing to act as a seal.

The remedy is to fit two rubber plugs, Part No. 22A64, each reduced in length by 3/16" (say, 4 to 5 mm.). Their combined length will provide just the right amount of 'spread' when the retaining screw 'E' is home.

In all cases of oil leakage into the clutch, the clutch friction surfaces should be examined and thoroughly cleaned, the driven plate being replaced if more than slightly contaminated.

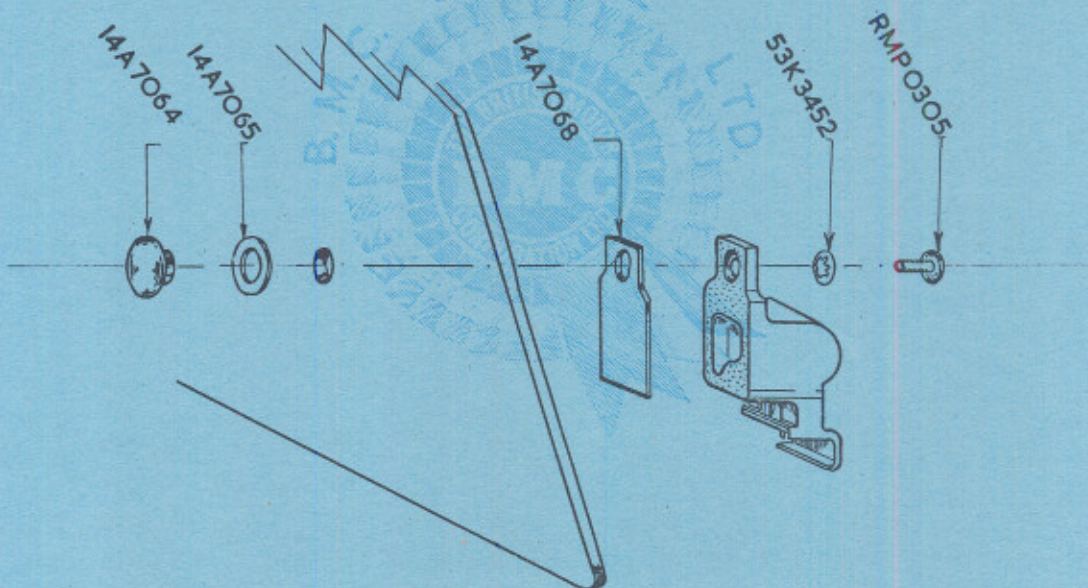
## WINDOW CATCH ASSEMBLIES

There is a possibility that these may become loose and pivot around their fixing points.

The remedy is to remove the catch and to coat each side of the fibre washer, Part No. 14A7068, with Dunlop adhesive S 758. An additional shakeproof washer, Part No. 53K3452, should be fitted also, as shown in the sketch below.

N.B. It is possible that the washers fitted to some early cars are not of fibre but a folded type.

In this case new fibre washers, Part No. 14A7068, should be used.

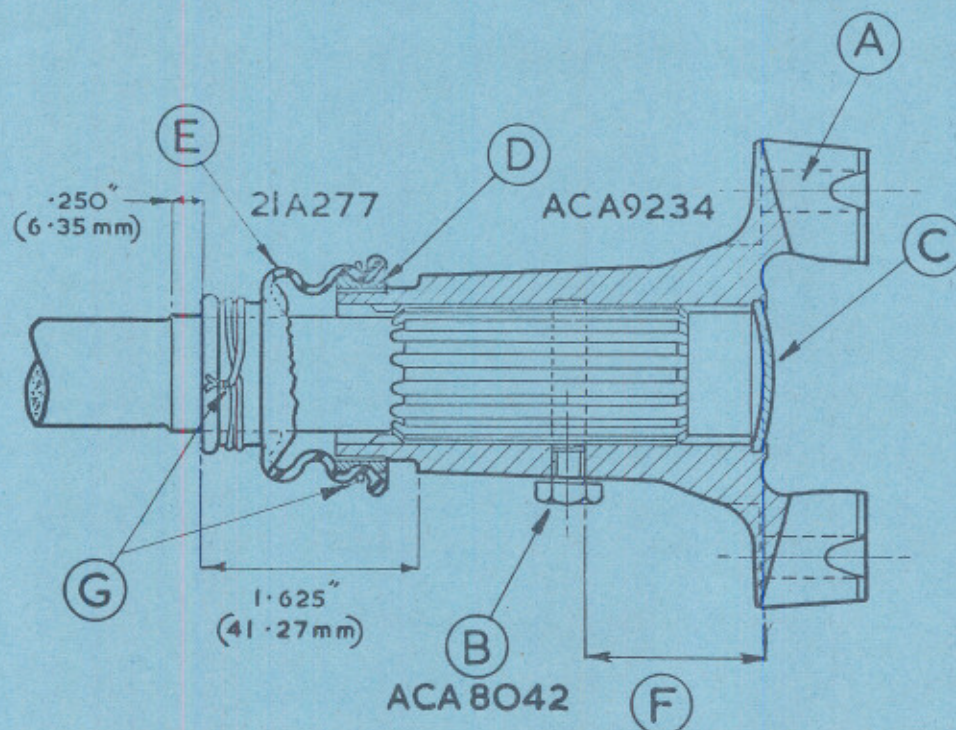
## DRIVE-SHAFT ASSEMBLY - 'KNOCK' FROM INNER JOINT

A 'knock' emanating from the splined coupling at the inner end of the drive-shaft assembly may be attributed to insufficient slip between the shaft splines and the flange when the shaft is under load.

Complaints of this nature should be carefully analysed because a slight 'knock' could occur on new cars due to tightness of the splines which would tend to decrease in operation.

A 'knock' in the case of a car which has done a reasonable mileage can be eliminated by improving the lubrication of the parts. This is achieved by dismantling and packing with Duckham's LAMMOL, substituting a rubber bellows for the existing cap and seal with ventilated end-plug. No further lubrication will then be necessary until major overhaul.

- 1) Remove hub nut.
- 2) Remove nuts from top and bottom arm ball pivots. Remove steering tie-rod nut and free the taper.
- 3) Free top arm from ball pin taper and lever up to clear pin. Free bottom arm from ball pin taper and lift hub assembly. The hub assembly can then be withdrawn from the drive shaft.

- 4) Remove the lower arm pivot pin, also the 4 outer U-bolt nuts and U-bolts. The shaft can then be manoeuvred through the aperture in the valance.
- 5) Remove the joint flange 'A' and remove and discard the end cap and cork seal.
- 6) REMOVE AND DISCARD GREASER in the joint flange and blank the hole, using  $\frac{1}{4}$ " UNF x 3/16" long setscrew 'B', Part No. ACA8042.

- 7) Seal off the end plug 'C' by patching and soldering up the breather hole and soldering round the outside edge of the plug.
- 8) Screw seal ring 'D', Part No. ACA9234, on to the joint flange 'A', taking care not to score the outer face, otherwise the housing seal 'E' (Part No. 21A277) will be cut when wired to the ring.

- 9) Using Duckham's LAMMOL grease, Part No. 97H2465, fill cavity 'F' in joint flange, as shown.
- 10) Fix and wire housing seal 'E' to drive-shaft in position shown.

- 11) Fill cavity inside housing seal 'E' with Duckham's LAMMOL grease.
- 12) Insert drive-shaft assembly into joint flange to dimension shown in illustration, and wipe off extruded grease.

- 13) Fit and wire housing seal 'E' to seal ring 'D'.
- 14) Use 2 turns of soft iron wire 'G' for fixing housing seal, ensuring that ends of wire cannot puncture or damage the seal.

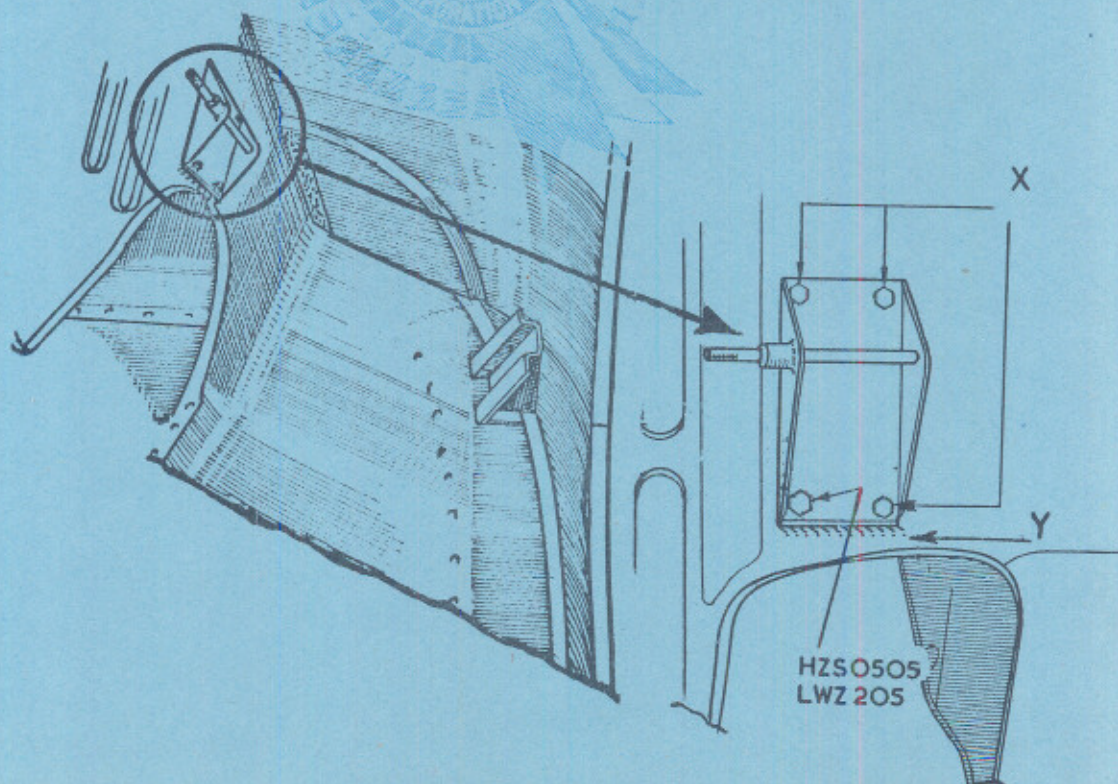
## FRONT SHOCK ABSORBER MOUNTING BRACKETS

If these brackets work loose the attachment should be reinforced as follows:

Remove the four existing screws and replace those marked 'X' with longer  $\frac{1}{4}$ " UNF screws (Part No. HZSO407), fitting nuts (Part No. FNZ104) and the original spring washers.

The hole for the fourth screw should be drilled out with a letter 'I' drill and tapped 5/16" UNF. A screw (Part No. HZSO505) and spring washer (Part No. LWZ205) should then be fitted. Finally, gas-weld the lower edge of the bracket to the wing valance as indicated at 'Y'.

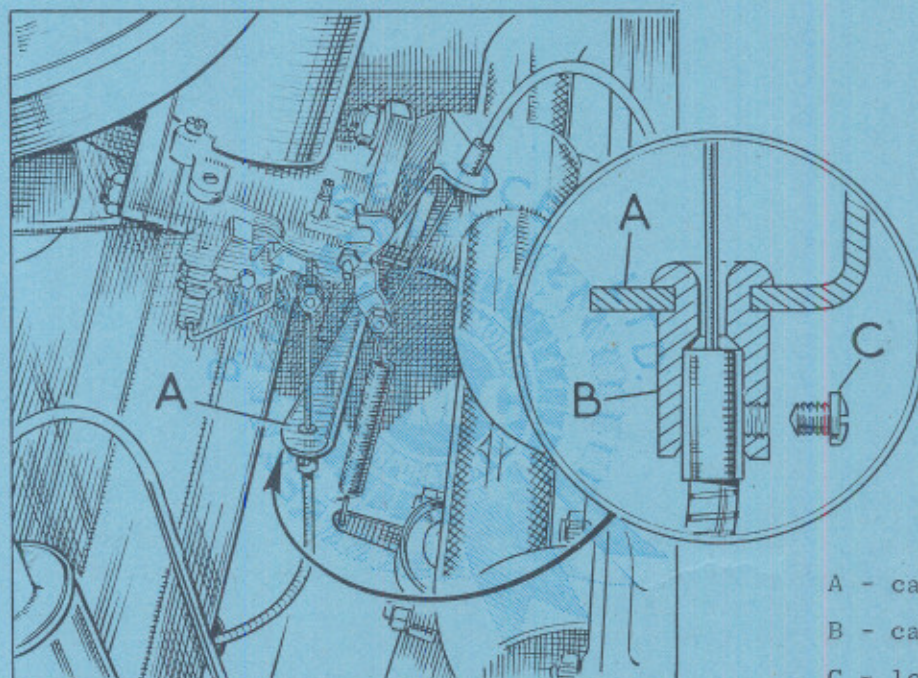
FIGURE I

1. Any tendency for the cable outer casing to jump out of its abutment in the stop (Part No. 12A2) can be prevented by locking the cable in position with self-threading screw ACA8041 (drill size 43), as shown in Fig. 1.

- A - cable stop bracket
- B - cable abutment
- C - locking screw.

It will be appreciated that, with the outer casing out of its abutment, the carburettor cam lever cannot return to the "weak" position and the result is an over-rich running mixture with increased fuel consumption.

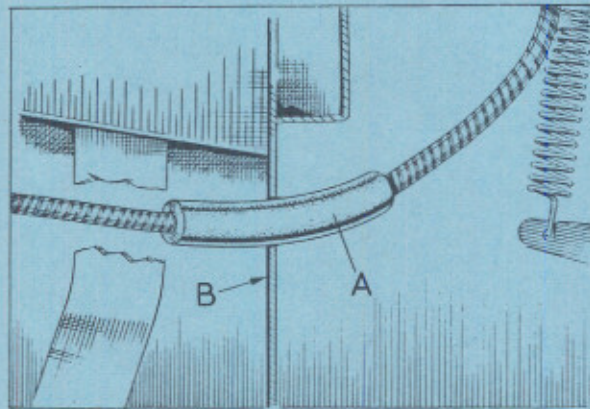
FIGURE 2

2. A tendency exists for the choke cable rubber grommet, protecting the cable casing in the dash panel, to be pulled out of position during marked engine vibration, thereby causing damage to the cable. This can be remedied by replacing the existing grommet with a rubber sleeve to allow for backward and forward "slide".

To achieve this modification, disconnect the choke cable at the carburetter and withdraw the cable from the bracket. Remove the existing rubber grommet from the cable and replace with the new rubber sleeve 'A' (Part No. 21A227) which should be positioned in the dash panel 'B' (Fig. 2) as illustrated. Re-connect the cable at the carburetter.

Alternatively a grommet, Part No. 14A7212, is available which will improve the sealing of the dash and may be fitted to existing cars if the hole in the dash is enlarged to 5/8" (say, 16 mm.). This new grommet will be fitted in production in the near future.

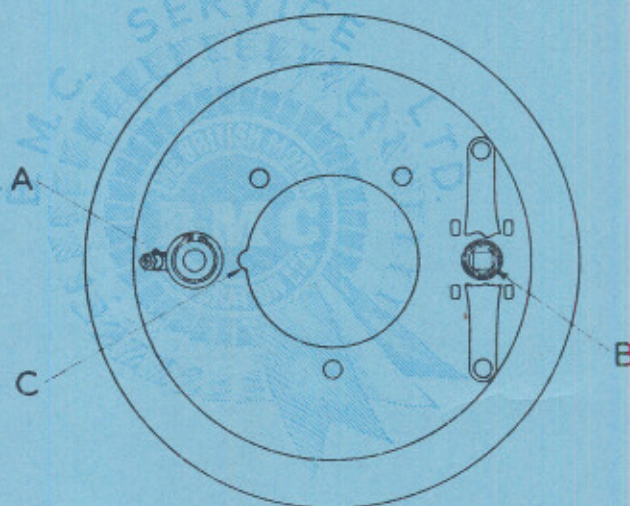
## WATER IN FRONT BRAKES

This may be prevented by sealing certain points on the outside of the front brake backplate, using Bostik 252.

'A' is the wheel cylinder boss. Particular attention to sealing should be given between the bleeder screw and the boss.

'B' is the joint between the adjuster reinforcing plate and the hole in the backplate.

'C' (LEFT-HAND BACKPLATE ONLY) is the identification hole.

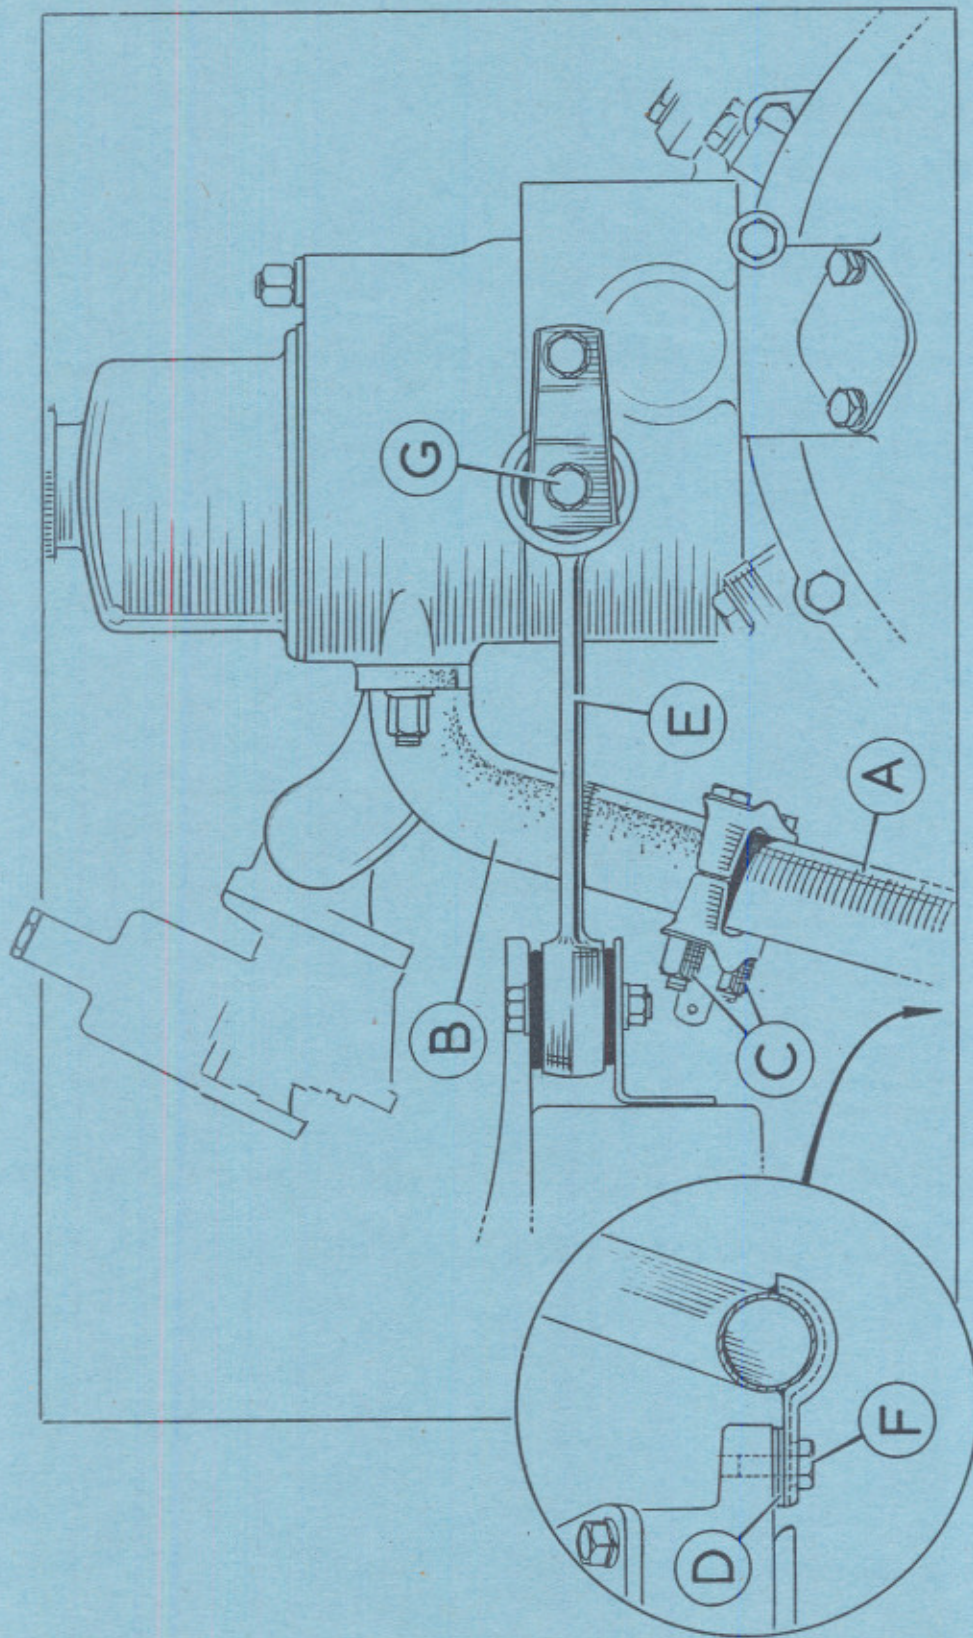
## ENGINE VIBRATION

When there is a tendency towards engine vibration, slacken the fixings of the exhaust system and engine steady rod and re-adjust these components in accordance with the following sequence of instructions (these also apply when the engine is removed for overhaul or when the exhaust system is changed):

1. Position the exhaust pipe and silencer assembly 'A' (see illustration overleaf) to the exhaust manifold 'B' and leave the exhaust pipe clamp securing nuts 'C' just slack.
2. Re-secure the exhaust pipe and silencer at the two locations on the rear sub-frame.
3. Place spacing washers 'D' (PWZ105) between the exhaust support stay and the lug on the gear change extension casing until the hole for the engine steady rod bolt at the top of the cylinder block moves into line with the metal bush in the rubber of the engine steady rod 'E'.
4. Replace and tighten the securing bolt 'F' to secure the exhaust support to the gearbox lug.
5. Insert the setscrew 'G' into the cylinder block, through the engine steady bracket and steady rod bush, and tighten.
6. Tighten the securing nuts 'C' on the exhaust pipe clamp.

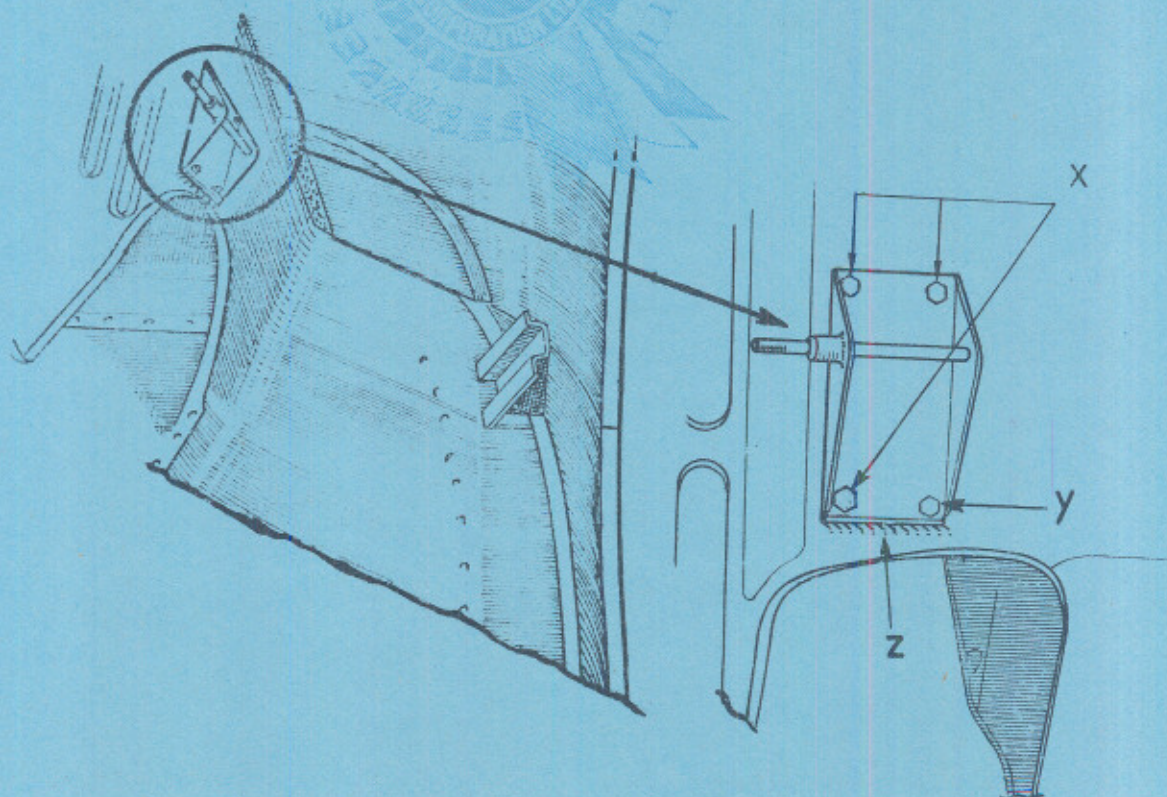
## FRONT SHOCK ABSORBER MOUNTING BRACKETS

If these brackets work loose the attachment should be reinforced as follows:

Remove the four existing screws and replace those marked 'X' with longer  $\frac{1}{4}$ " UNF screws (Part No. HZS0407), fitting nuts (Part No. FNZ104) and the original spring washers.

The hole for the fourth screw 'Y' should be drilled out with a letter 'I' drill and tapped 5/16" UNF. A screw (Part No. HZS0505) and spring washer (Part No. LWZ205) should then be fitted. Finally, gas-weld the lower edge of the bracket to the wing valance as indicated at 'Z'.

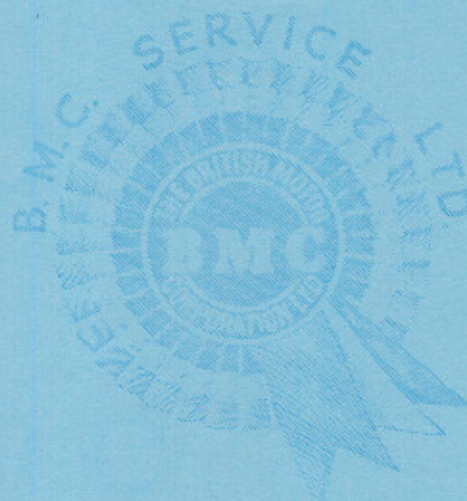
## CARPET UNDERFELT

Care should be taken when replacing carpets and underfelts to ensure that there is no possibility of the underfelt fouling the steering column pinch-bolt.

As an added precaution the hole in the underfelt (through which the column passes) should be enlarged from  $1\frac{1}{2}$ " (38 mm.) to  $2\frac{1}{2}$ " (63 mm.) diameter.

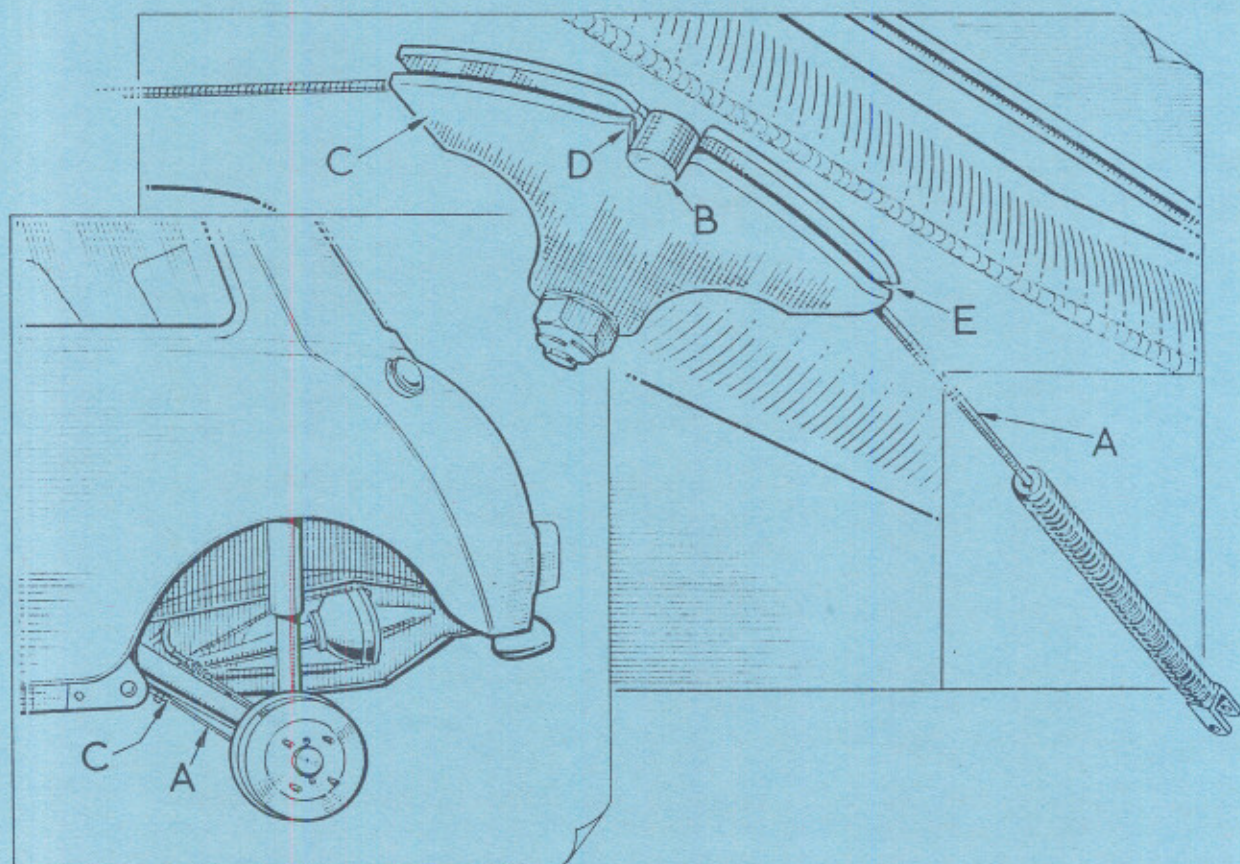
## HAND BRAKE CABLE

A recent improvement is a new hand brake cable assembly 'A', Part No. 21A186, incorporating a trunnion 'B' which engages with a sector 'C', Part No. 21A182, mounted on a hinge pin on the rear suspension radius arm (see sketch overleaf). This modified arrangement dispenses with the original cable, guide tube and clip on the radius arm.

In the event of replacement, on and from the foregoing car numbers, the following procedure is necessary to obtain the correct clearance between brake cable and tyre:

1. Assemble brake cable 'A' to sector 'C' with the positioning trunnion 'B' in the slot provided.
2. Corners 'D' and 'E' on the sector should then be 'nipped' thereby trapping the cable in the sector groove. It is important that only the two corners 'D' and 'E' are 'nipped' in order to position the cable for clearance when assembled to the rear sub-frame.
3. Refit the sector and bearing onto the hinge pin on the radius arm, and secure in position with plain washer (2K5806) and Nyloc nut (LNZ205).
4. Re-connect the brake cable to the actuating lever on the brake backplate.

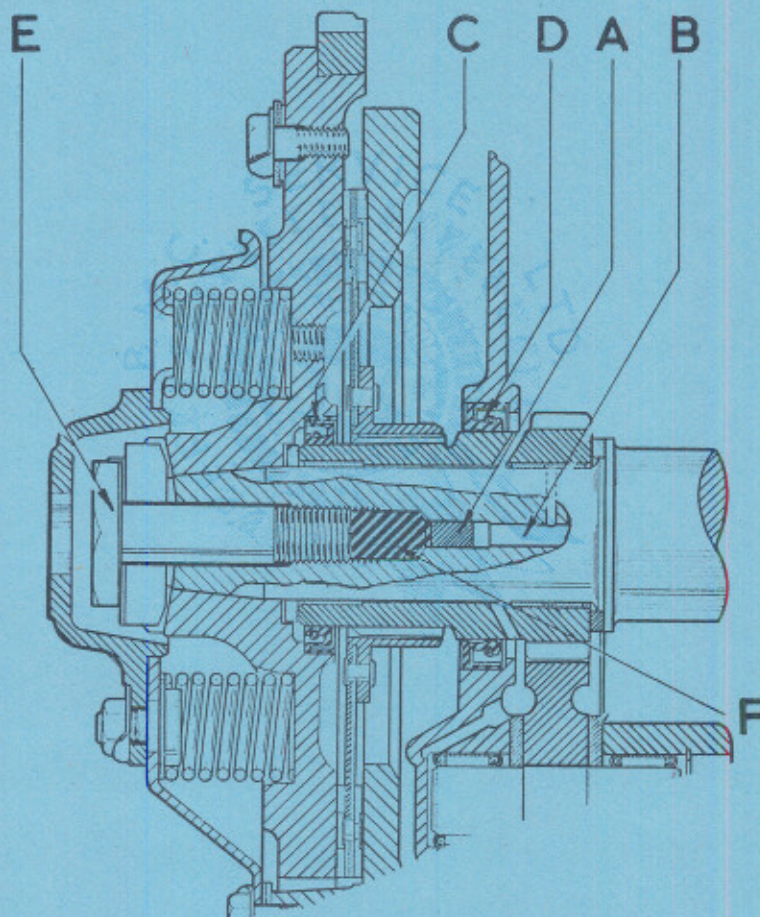
## OIL LEAKAGE INTO CLUTCH

There are three possible causes:

- (1) leakage past brass plug 'A' at end of oilway 'B'
- (2) leakage past seal 'C'
- (3) leakage past seal 'D'

To check for (1), withdraw flywheel retaining screw 'E'. If this is quite dry, the brass plug 'A' is not suspect and dismantling should proceed in order that seal 'D' may be examined. Leakage here would most likely be due to damage in assembly and a new seal should be fitted if necessary. Leakage at 'C' will be prevented by a new type seal, Part No. 13H435, which has a steel outer shell.

If, on the other hand, oil leakage is in evidence at (1), this may be due to the fact that the rubber plug 'F' (Part No. 22A64) - which is an added precaution against leakage at the brass plug 'A' - is not in contact with the tip of the retaining screw 'E', as intended, and has therefore not been 'spread' and is failing to act as a seal.

The remedy is to fit a longer ( $\frac{7}{8}$ " or 22.22 mm.) rubber plug, Part No. 22A124. The extra length will provide just the right amount of spread when the retaining screw 'E' is home.

In all cases of oil leakage into the clutch, the clutch friction surfaces should be examined and thoroughly cleaned, the driven plate being replaced if more than slightly contaminated.

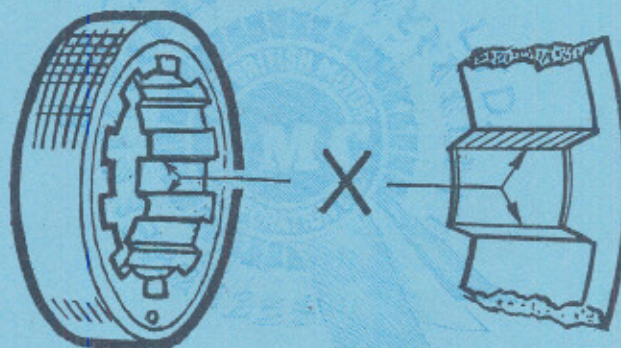
## THRUST WASHERS 2A3217, 2A3218, 2A3219

A recent investigation of cases of gearbox seizure has rendered the above parts suspect.

Stocks of these washers should be checked to ensure that there is no chamfer at points 'X', as this might result in the locking peg being over-ridden, the thrust washer and gears seizing on the third motion shaft as a consequence.

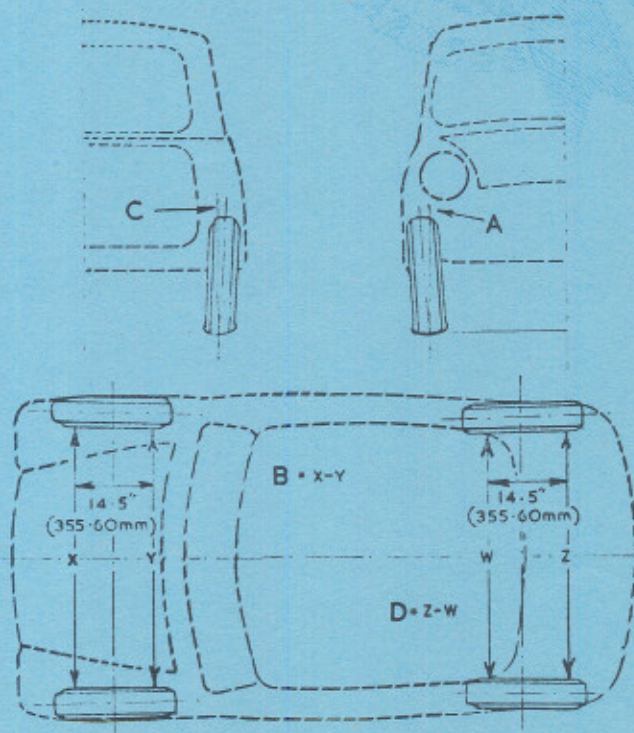
## STEERING WANDER

Complaints of steering wander prior to Car No. 11670 RHD or 10530 LHD may usually be disposed of by increasing the caster angle from  $1\frac{1}{2}^{\circ}$  to  $3^{\circ} \pm \frac{1}{2}^{\circ}$ .

Front wheels (A) Camber angle  $2^{\circ}$  positive  $\pm 1^{\circ}$

(B) Toe OUT  $1/16''$  (1.6 mm.)

Rear wheels (C) Camber angle  $1^{\circ}$  positive  $\pm \frac{1}{2}^{\circ}$

(D) Toe IN  $\frac{1}{8}''$  (3.2 mm.)  $\pm \frac{1}{8}''$  (3.2 mm.)

This is achieved by fitting a pair of the shorter tie-rods. Part No. 21A263, which were introduced at the above Car No. and which must now be used for all service replacements (PAU/826 refers).

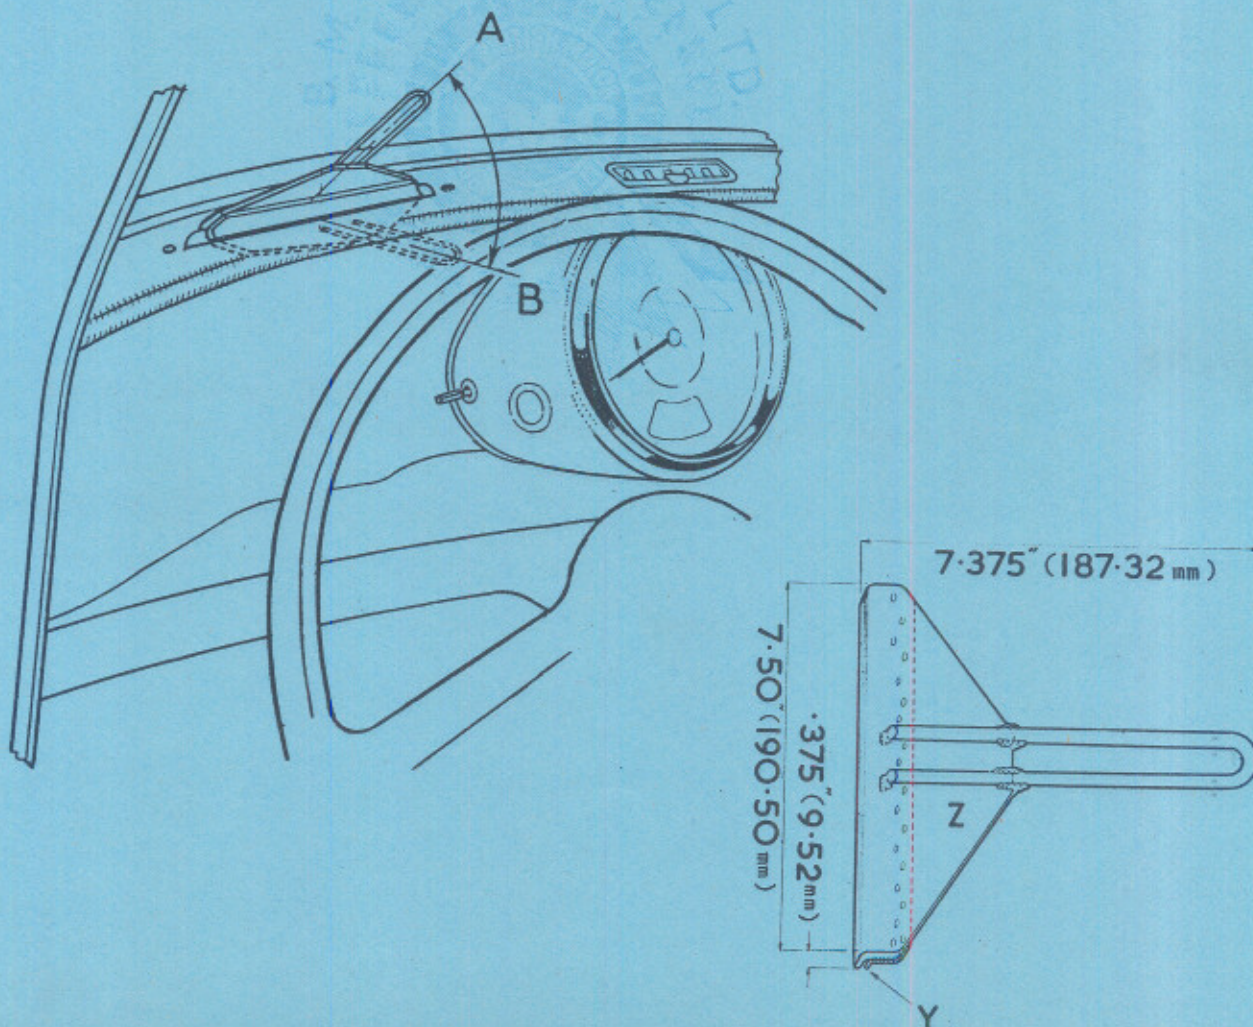
## INADEQUATE DEMISTING

In cases where demisting is unsatisfactory, the following operation is recommended to enable air to be directed over a larger area of the windscreen:

1. Make up a tool of mild steel, using 10 S.W.G. (3.25 mm.) for 'Z' and 13 S.W.G. (2.33 mm.) for jaw 'Y' which is welded to 'Z' as shown. Take care to round and smooth all edges.
2. Position jaws of tool over the demister shield in position 'A'.
3. Press down on handle of tool to position 'B', i.e., approximately in line with steering wheel rim.
