Distributor & Dealer  
Organization

26 January 1960

## PETROL TANK

SEVEN

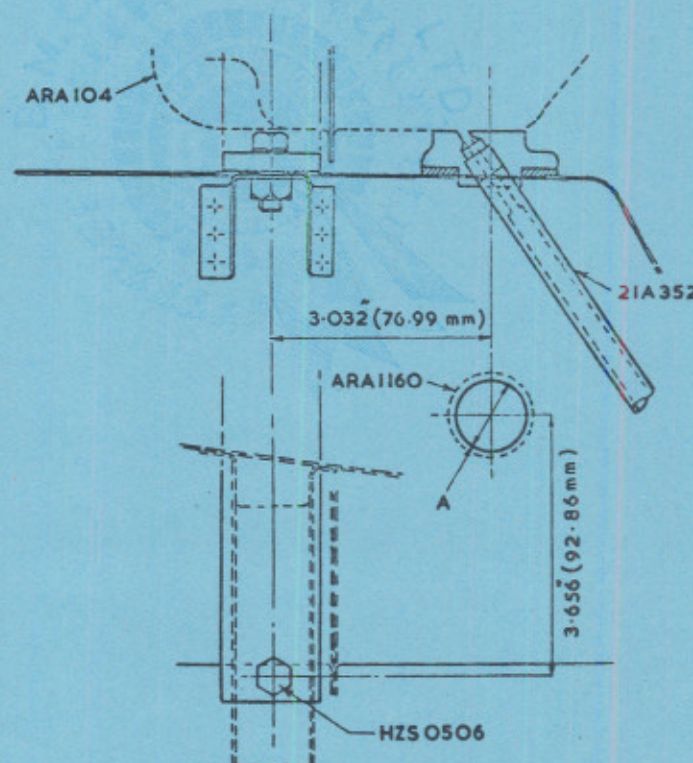
A modified petrol tank, Part No. ARA104, incorporating a drain plug & tube assembly, Part No. 21A352, was introduced at Body No. 10906 (plus 10811 to 10900) and this must be used for all service replacements.

To fit the new tank to earlier cars it will be necessary to provide a  $1 \frac{1}{16}$  (26.99 mm.) diameter hole in the boot floor (as shown at 'A' in sketch)  $3 \frac{1}{32}$  (76.99 mm.) from the centre line of the strap fixing bolt HZS0506. A dust seal, Part No. ARA1160, should be fitted around this hole.

N.B. The drain plug & tube assembly must not be fitted to the tank until after the tank is in position in the vehicle.

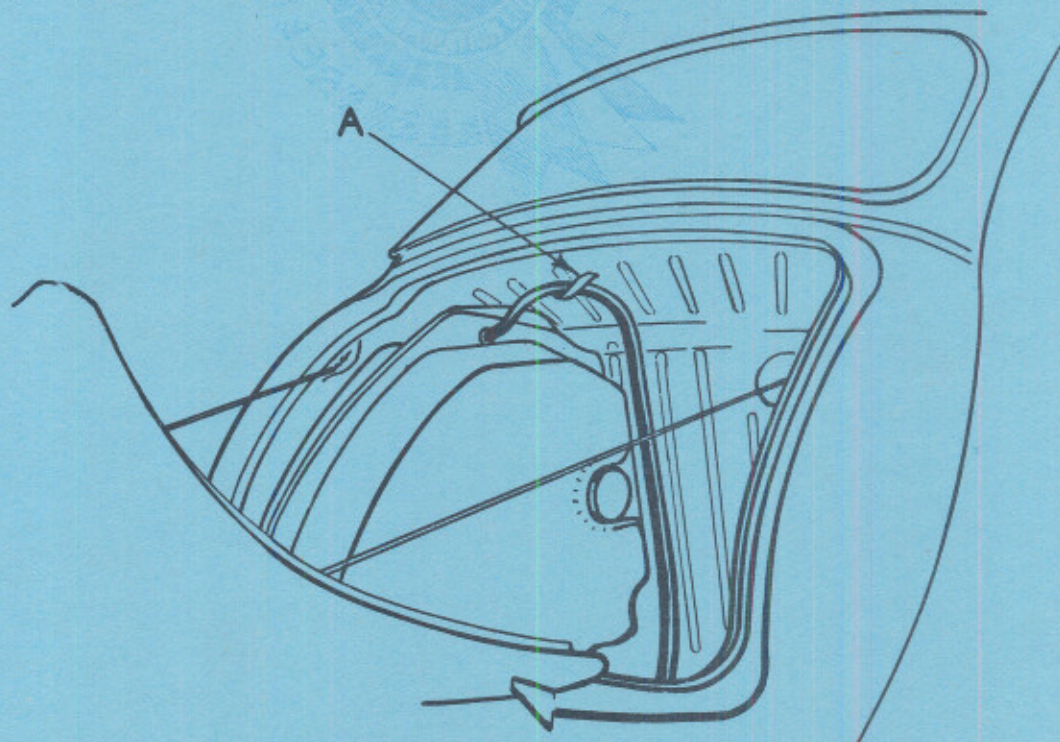
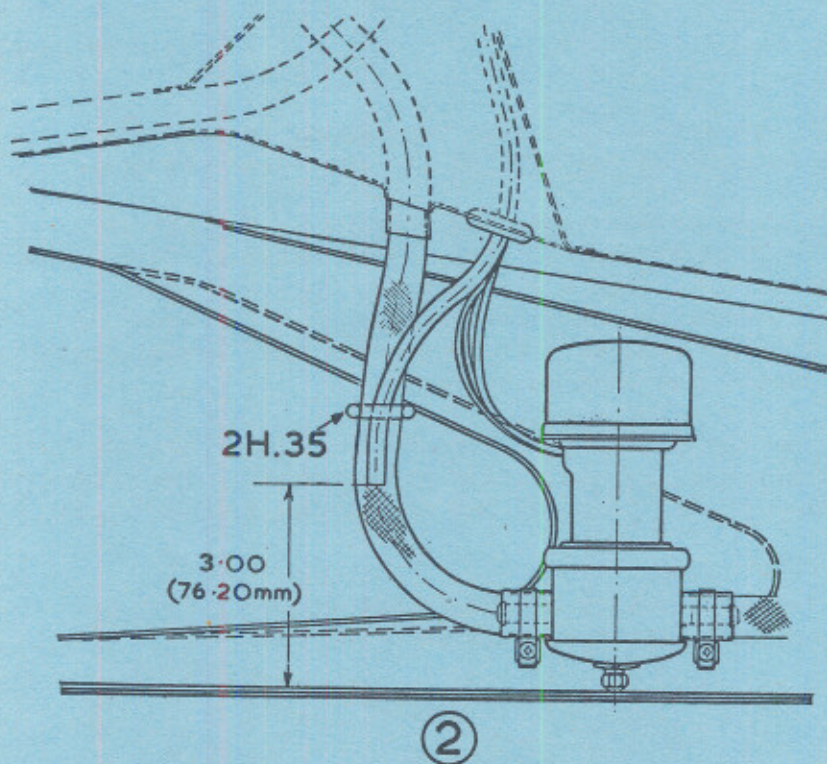
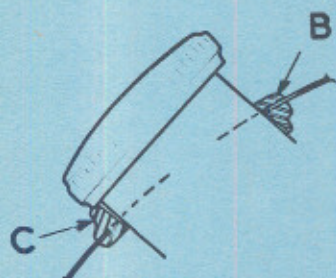
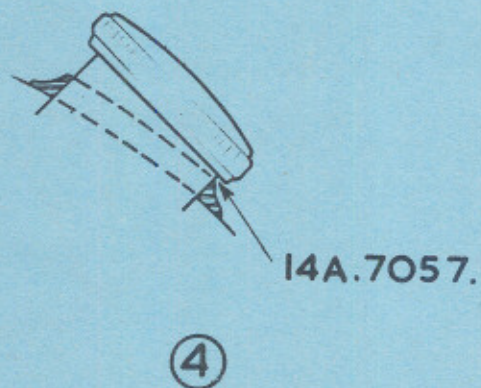
This may be due to the petrol tank vent pipe being incorrectly positioned and drawing water from the base of the sub-frame channel.

Water may also enter the petrol tank through the filler cap if it is prevented from seating properly by the filler pipe grommet. The grommet should be fitted as shown at 'B' (Fig. 3) and not upside down as shown at 'C'.

The vent pipe should be re-positioned by looping it as high as possible in the boot, utilising clip 'A' (Fig. 1) if fitted. Secure end of pipe to flexible petrol pipe with a rubber ring, Part No. 2H35, approximately 3" (76 mm.) from the base of the sub-frame (as shown in Fig. 2 overleaf). It will be necessary to disconnect the flexible petrol pipe from the pump to thread the ring on to it.

Fig. 4 shows the correct fitting of the latest grommet, Part No. 14A7057, introduced to prevent water leakage into the boot.

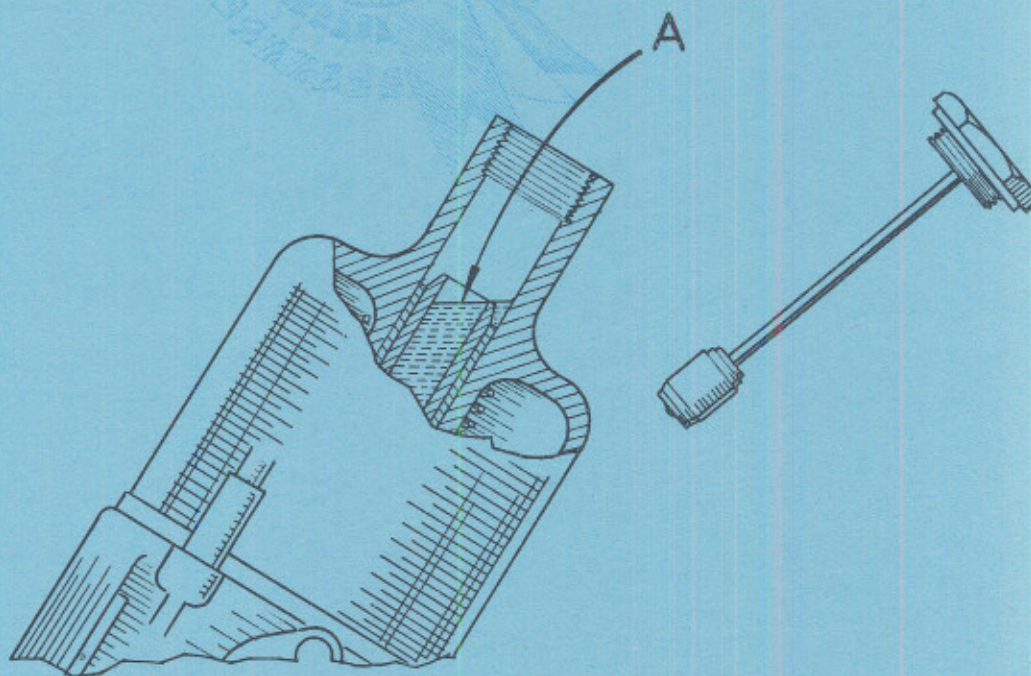
If corrosion and sticking of the rod are to be avoided, the oil level in the reservoir must not be allowed to fall below the level indicated at 'A' in the sketch below.

Particular attention must be drawn to the instructions in the Driver's Handbook and Workshop Manual regarding the topping-up of the carburetter damper oil reservoir every 1,000 miles.

Only S.A.E. 20 oil must be used, whatever the climatic conditions.

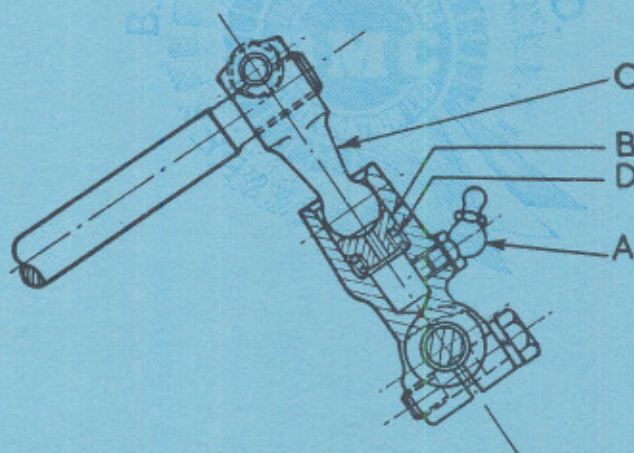
This may be caused by over-lubrication of remote control shaft lever grease nipple 'A', which would result in grease being packed behind thrust button 'B', thus putting considerable end-thrust on lever 'C'.

Thrust button 'B' and spring 'D' were deleted at Engine No. 8A-U-H6612 to prevent this possibility.

As removal of the thrust button is a considerable operation involving taking out the power unit, it is recommended that the grease nipple 'A' be removed from cars in service to prevent pressure lubrication at this point.

Attention at major overhaul periods is all that is necessary; the Workshop Manual and Driver's Handbook will be amended accordingly.

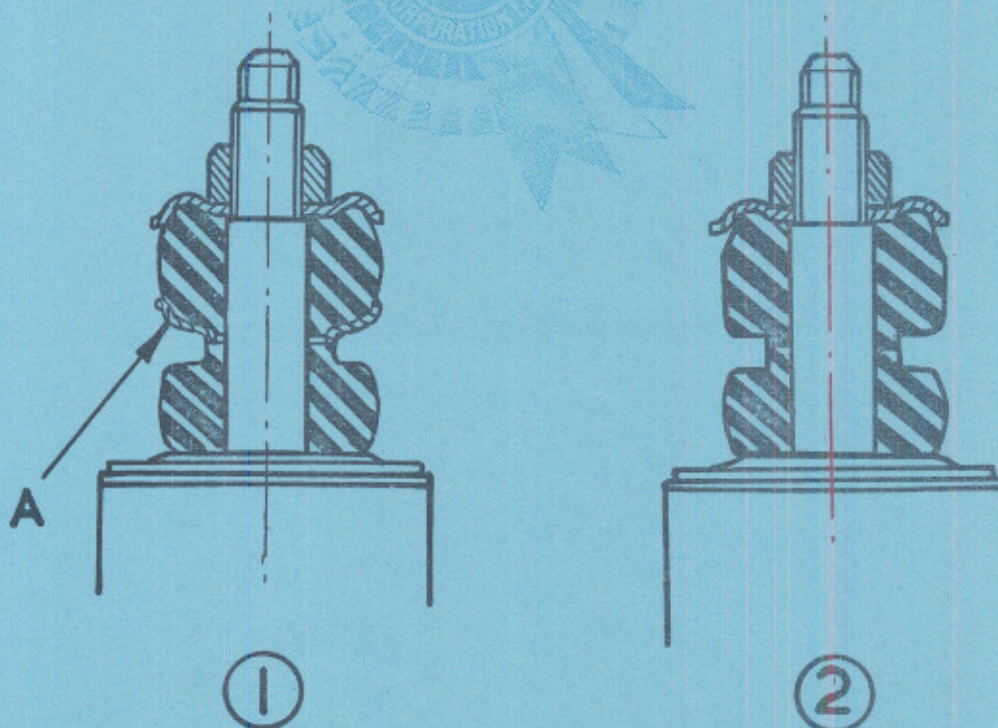
A revised top mounting rubber has been introduced for the rear shock-absorber of this model.

Fig. 1 below shows the old arrangement, and Fig. 2 the new.

Only the latest type top rubber, Part No. 27H1865 (Armstrong), 17H4733 (Girling), will be supplied for service, although shock-absorber assemblies may have either type fitted.

If it is necessary to fit the latest type top rubber in place of the old pattern, the washer 'A' will not be required and should be discarded. Both shock-absorbers should, preferably, have the same type top rubber fitted.

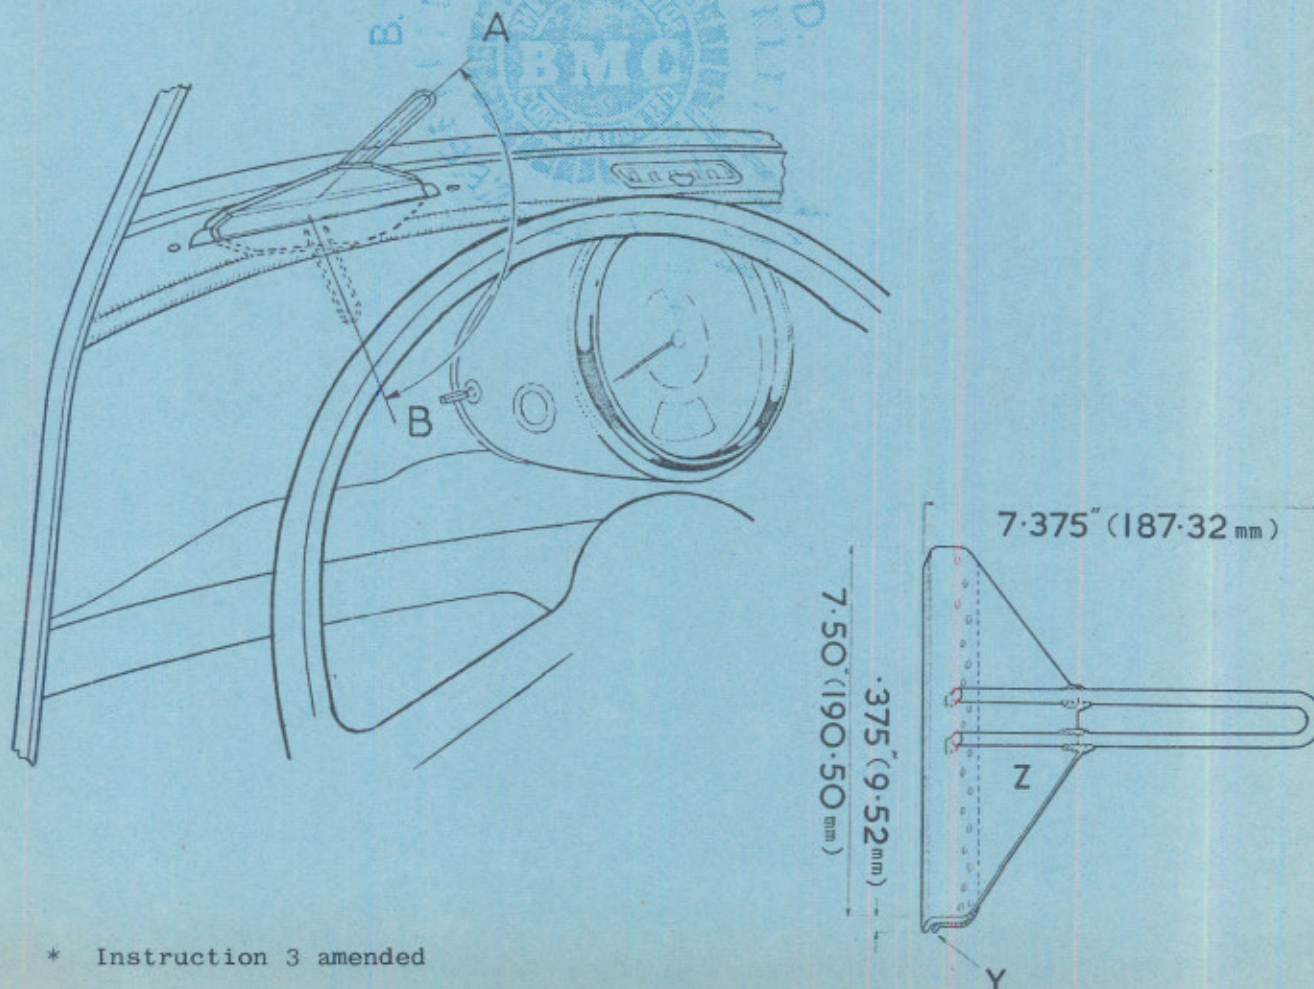
In cases where demisting is unsatisfactory, the following operation is recommended to enable air to be directed over a larger area of the windscreen:

1. Make up the tool illustrated below, using 10 S.W.G. (3.25 mm.) mild steel for 'Z' and 13 S.W.G. (2.33 mm.) mild steel for jaw 'Y', which is welded to 'Z' as shown. Take care to round and smooth all edges.
2. Position jaws of tool over the demister as at 'A'.
3. Press down on handle of tool to position 'B', i.e. until contact is just made with fascia.

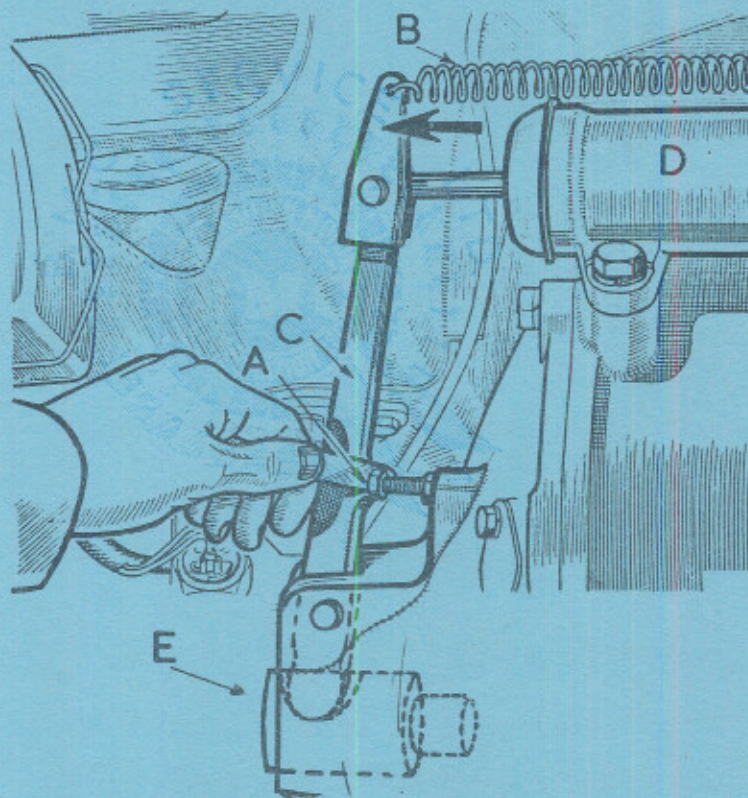
It is of the utmost importance that the clutch withdrawal mechanism does not permit overthrow.

The design calls for only sufficient throw to free the driven plate and the requisite amount is regulated by the adjustable stop 'A'. The clearance here is normally .060" (1.52 mm.) - this is the MINIMUM permissible - but it may be increased to a MAXIMUM of .075" (1.91 mm.) as described later.

There are, however, two factors which may bring about overthrow and these have nothing to do with the adjustment at 'A':

- (1) Stiffness in the operating mechanism, resulting in failure of spring 'B' (Part No. 22A5) to return lever 'C' to stop 'A'. (This means in effect that the clearance given at 'A' will be ADDED to the travel of the piston in slave cylinder 'D' on the subsequent operation of the clutch and overthrow will consequently take place)
- (2) Clutch pressure springs, Part No. 22A6, not to specification, with the result that they become coil-bound in normal clutch operation.

The possible results of clutch overthrow can be serious, since the crankshaft thrust washers will have to contend with loads many times in excess of those for which they were designed. The washers might, in fact, disintegrate and drop down into the transmission; at best they would wear excessively.

To counteract (1), a stronger spring, Part No. 1G5999, is now fitted in production and, as regards (2), a must closer inspection has been imposed.

ALL CARS SHOULD HAVE THE CLUTCH OPERATION CHECKED AS A ROUTINE PRECAUTION, as follows:

(a) Warm up engine and allow to tick over at a speed not exceeding 500 r.m.p. Depress clutch pedal and release normally, repeating these operations three or four times without pause. If engine slows down appreciably or ultimately stalls, change spring 'B' for Part No. 1G5999 and repeat test.

(b) If the slowing-down and stalling still occur, the clutch pressure springs are suspect, as in (2) overleaf, and the effect of increasing the clearance at 'A' to the MAXIMUM of .075" (1.91mm.) should be tried.

(c) Should this prove of no avail, it will be necessary to fit a new set of clutch springs (see Note (i) below).

Overthrow due to stiffness - (1) overleaf - will almost certainly be overcome by the substitution of the stronger spring 1G5999. At the same time, any obvious causes of stiffness - e.g., a partial seizure of the throw-out plunger at 'E' or stickiness at this point due to an excess of paint, should naturally be dealt with.

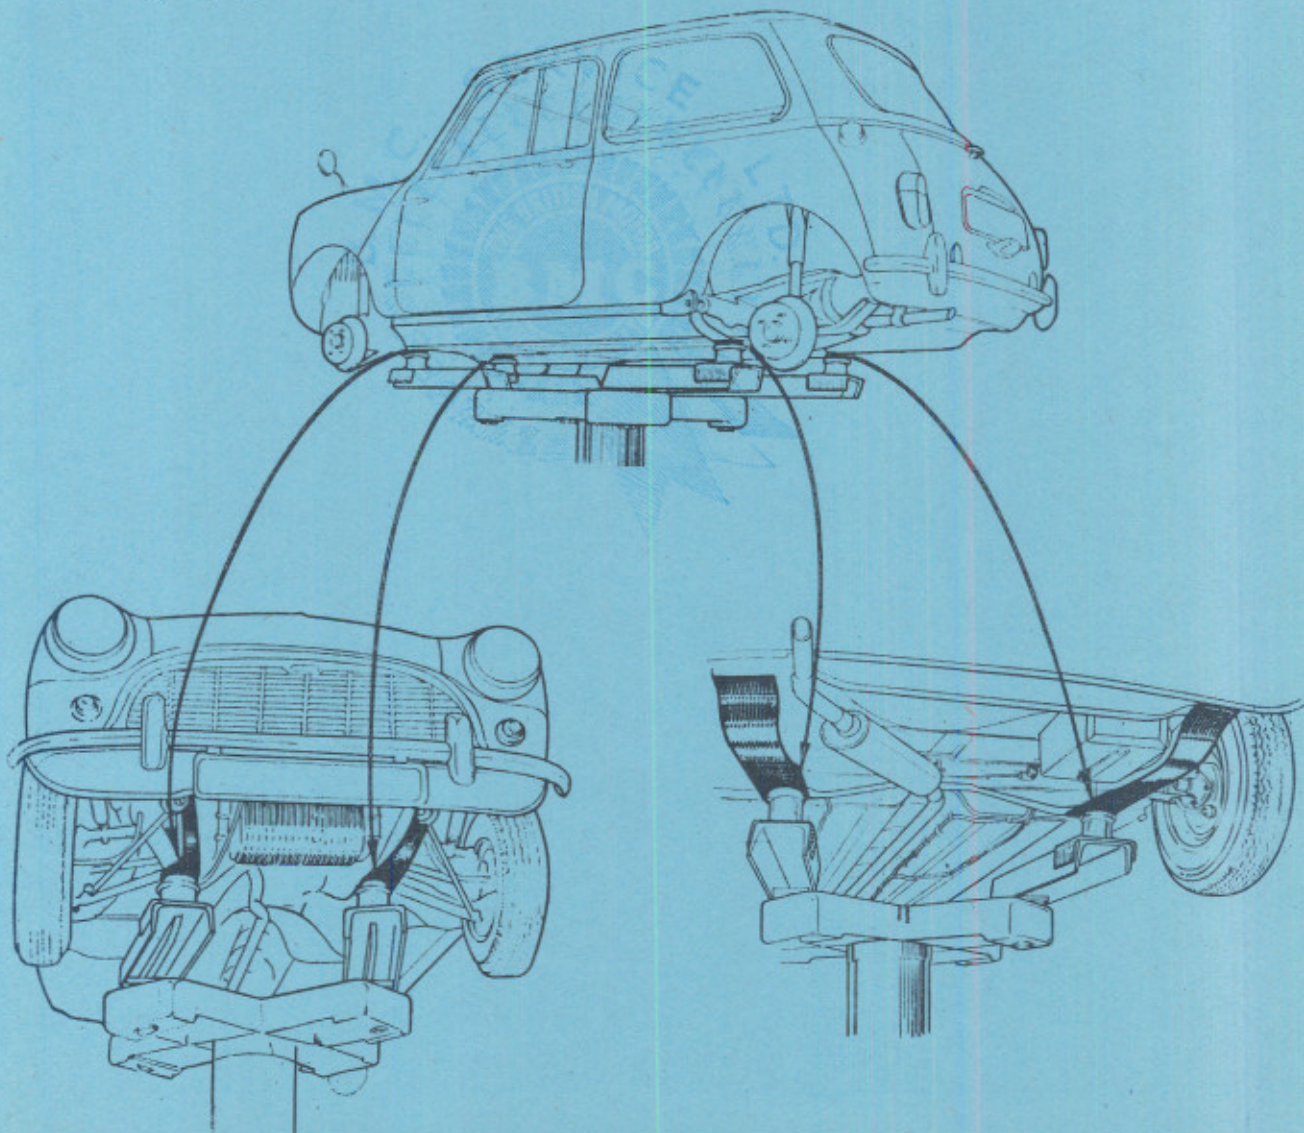
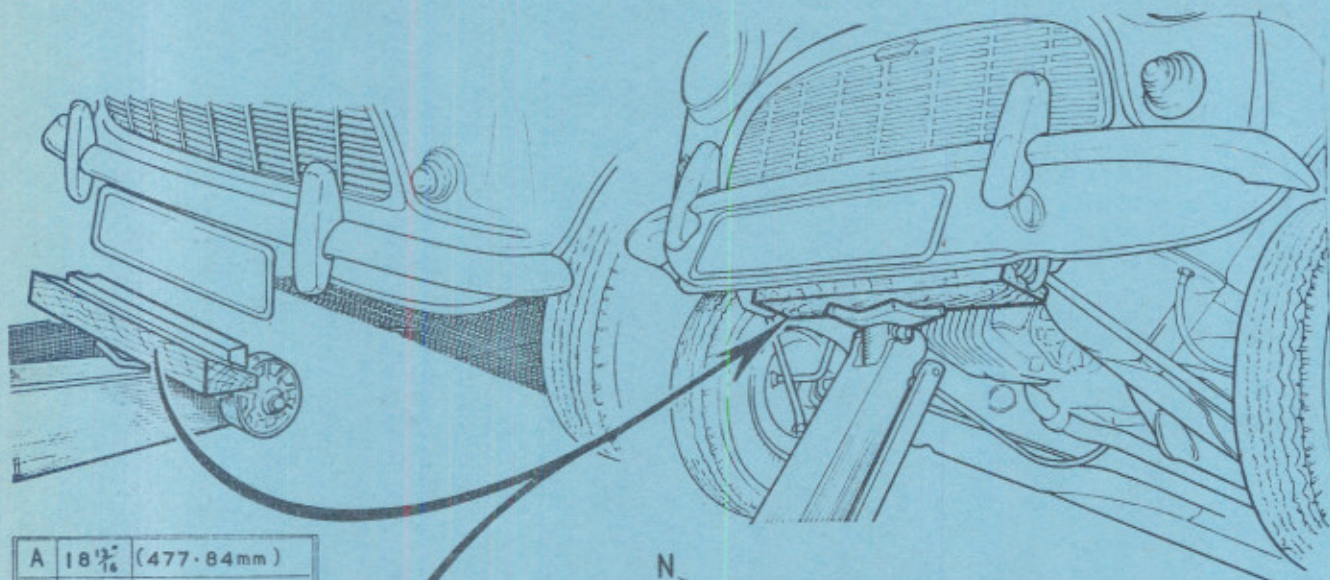
Incorrect jacking may lead to distortion of the floor panels and possible failure of the floor weather-sealing.

The illustrations show the proper application of normal garage jacking equipment.

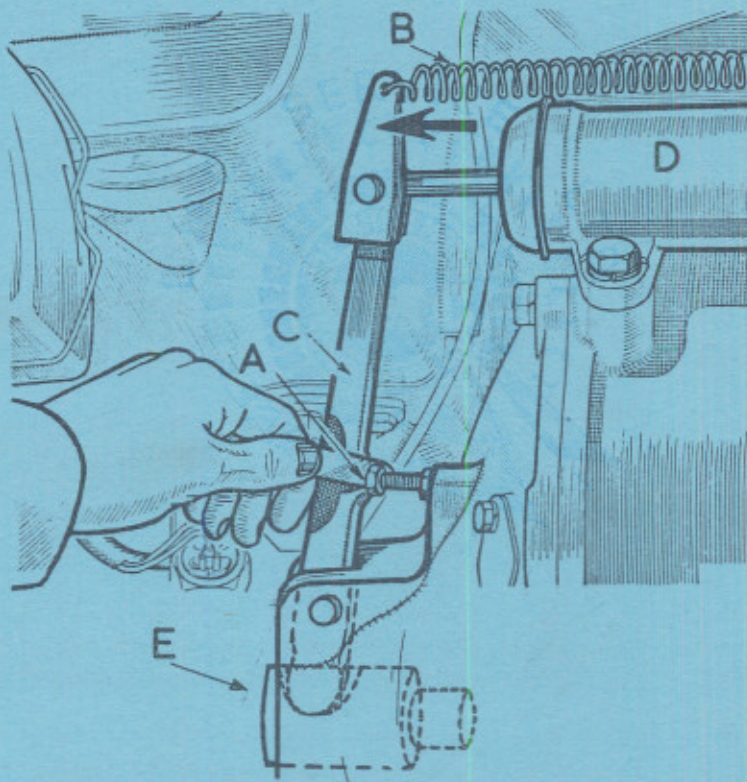
It is of the utmost importance that the clutch withdrawal mechanism does not permit overthrow.

The design calls for only sufficient throw to free the driven plate and the requisite amount is regulated by the adjustable stop 'A'. The clearance here is normally .060" (1.52 mm.) - this is the MINIMUM permissible - but it may be increased to a MAXIMUM of .075" (1.91 mm.) as described later.

There are, however, two factors which may bring about overthrow and these have nothing to do with the adjustment at 'A':

- (1) Stiffness in the operating mechanism, resulting in failure of spring 'B' (Part No. 22A5) to return lever 'C' to stop 'A'. (This means in effect that the clearance given at 'A' will be ADDED to the travel of the piston in slave cylinder 'D' on the subsequent operation of the clutch and overthrow will consequently take place);
- (2) Clutch pressure springs, Part No. 22A6, not to specification, with the result that they become coil-bound in normal clutch operation.

The possible results of clutch overthrow can be serious, since the crankshaft thrust washers will have to contend with loads many times in excess of those for which they were designed. The washers might, in fact, disintegrate and drop down into the transmission; at best they would wear excessively.

To counteract (1), a stronger spring, Part No. 1G5999, is now fitted in production and, as regards (2), a much closer inspection has been imposed.

ALL CARS SHOULD HAVE THE CLUTCH OPERATION CHECKED AS A ROUTINE PRECAUTION, as follows:

(a) Warm up engine and allow to tick over at a speed not exceeding 500 r.p.m. Depress clutch pedal and release normally, repeating these operations three or four times without pause. If engine slows down appreciably or ultimately stalls, change spring 'B' for Part No. 1G5999 and repeat test.

(b) If the slowing-down and stalling still occur, the clutch pressure springs are suspect, as in (2) overleaf, and the effect of increasing the clearance at 'A' to the MAXIMUM of .075" (1.91 mm.) should be tried.

(c) Should this prove of no avail, it will be necessary to fit a new set of clutch springs (See Note (i) below).

Overthrow due to stiffness - (1) overleaf --will almost certainly be overcome by the substitution of the stronger spring 1G5999. At the same time, any obvious causes of stiffness --e.g., a partial seizure of the throw-out plunger at 'E' or stickiness at this point due to an excess of paint, should naturally be dealt with.

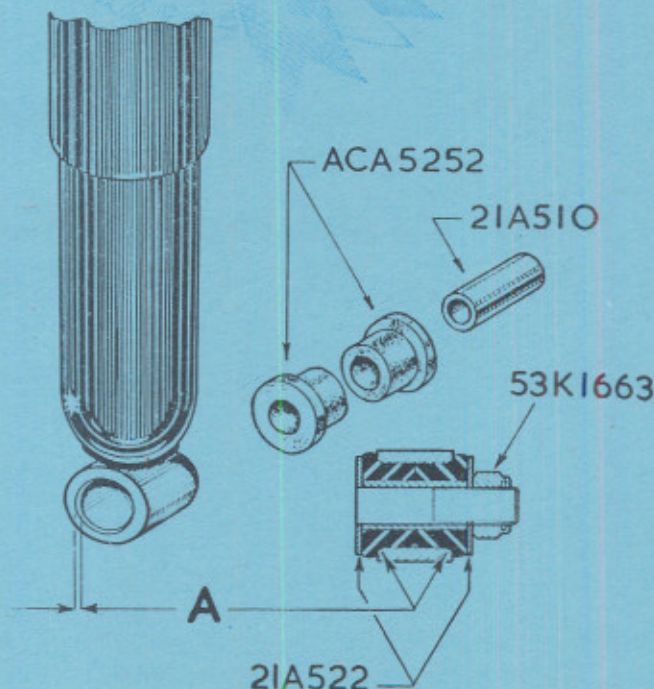
A more positive lower fixing may be provided in the event of failure of the standard arrangement. The improvement might also be conveniently made when the shock-absorbers are serviced:

Ensure that both sides of the damper eye at 'A' have a chamfer of .025" (.63 mm.) x 90° (Armstrong) or .046" (1.20 mm.) x 60° (Girling).

Modify by fitting twin-shouldered rubber bushes, a metal sleeve and metal retaining washers, as follows:

- (1) press out existing rubber bush
- (2) press in bushes, Part No. ACA5252
- (3) push in metal sleeve, Part No. 21A510
- (4) position metal retaining washers, Part No. 21A522
- (5) lock up nut, Part No. 53K1663.

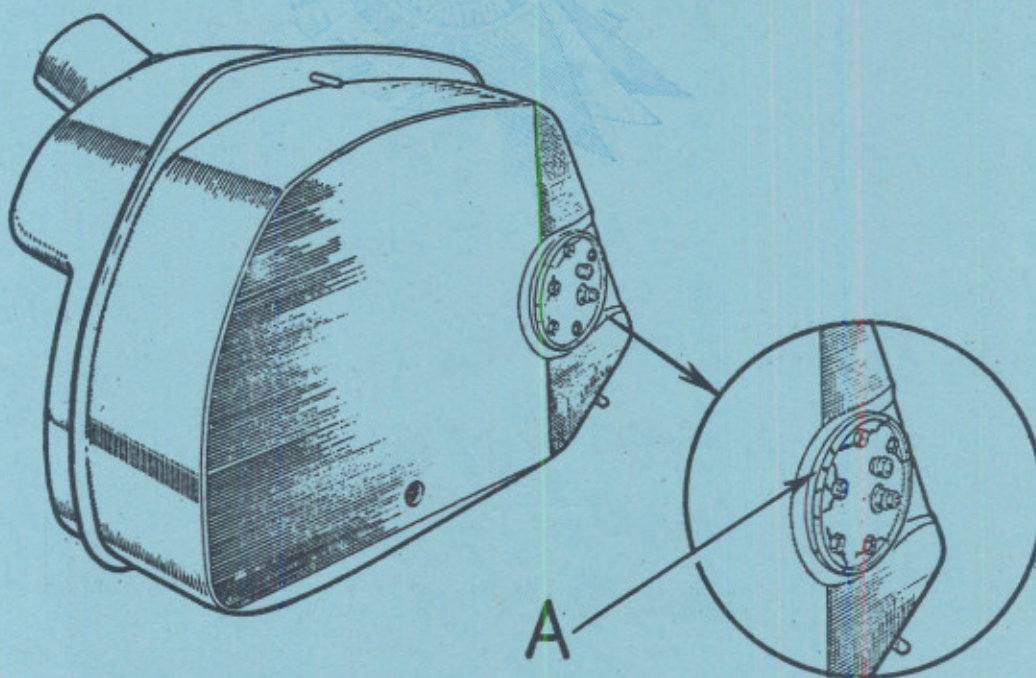
Over-tightening the fixing screws may lead to cracking of the flange at 'A'.

The gauge unit should be carefully inspected and replaced, if cracked, together with a new joint washer, Part No. 2H1082.

A suitable sealing compound (e.g. "Holdtite") should be used on both sides of the joint washer and also on the fixing screws which should be tightened evenly without excessive pressure.

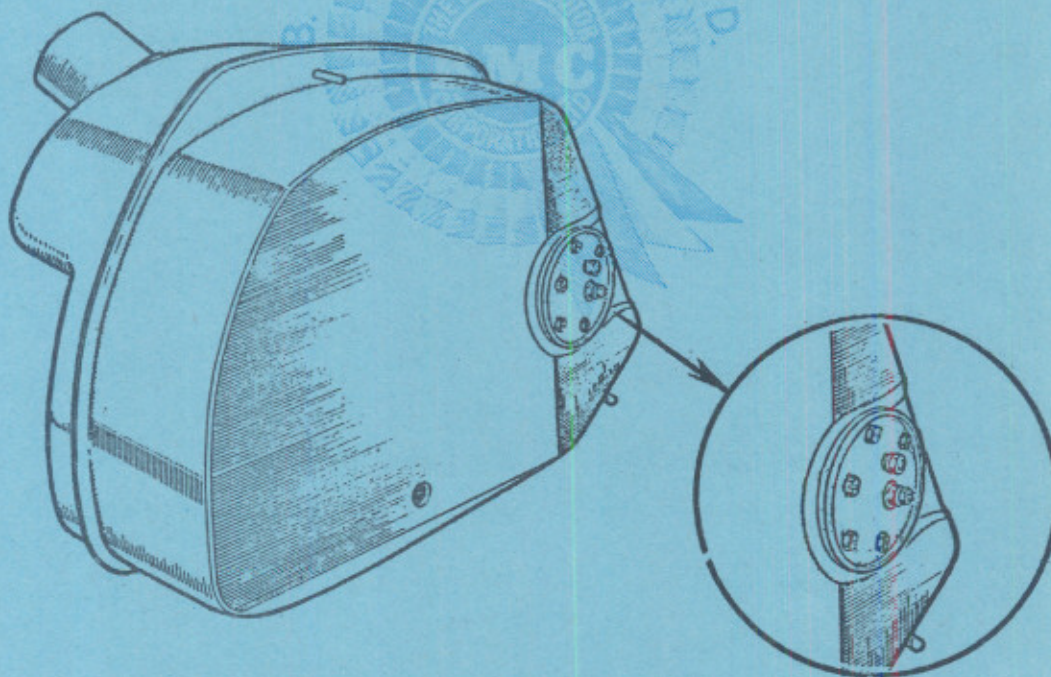
Over-tightening the fixing screws may lead to damage to the flange.

The gauge unit should be carefully inspected and replaced, if damaged, together with a new joint washer, Part No. 2H1082.

A suitable sealing compound (e.g. "Holdtite") should be used on both sides of the joint washer and also on the fixing screws which should be tightened evenly without excessive pressure.
