**B.M.C. SERVICE LTD.  
COWLEY, OXFORD**

# INDEX TO

## IMPROVEMENTS AND ALTERATIONS

**AUSTIN SEVEN**

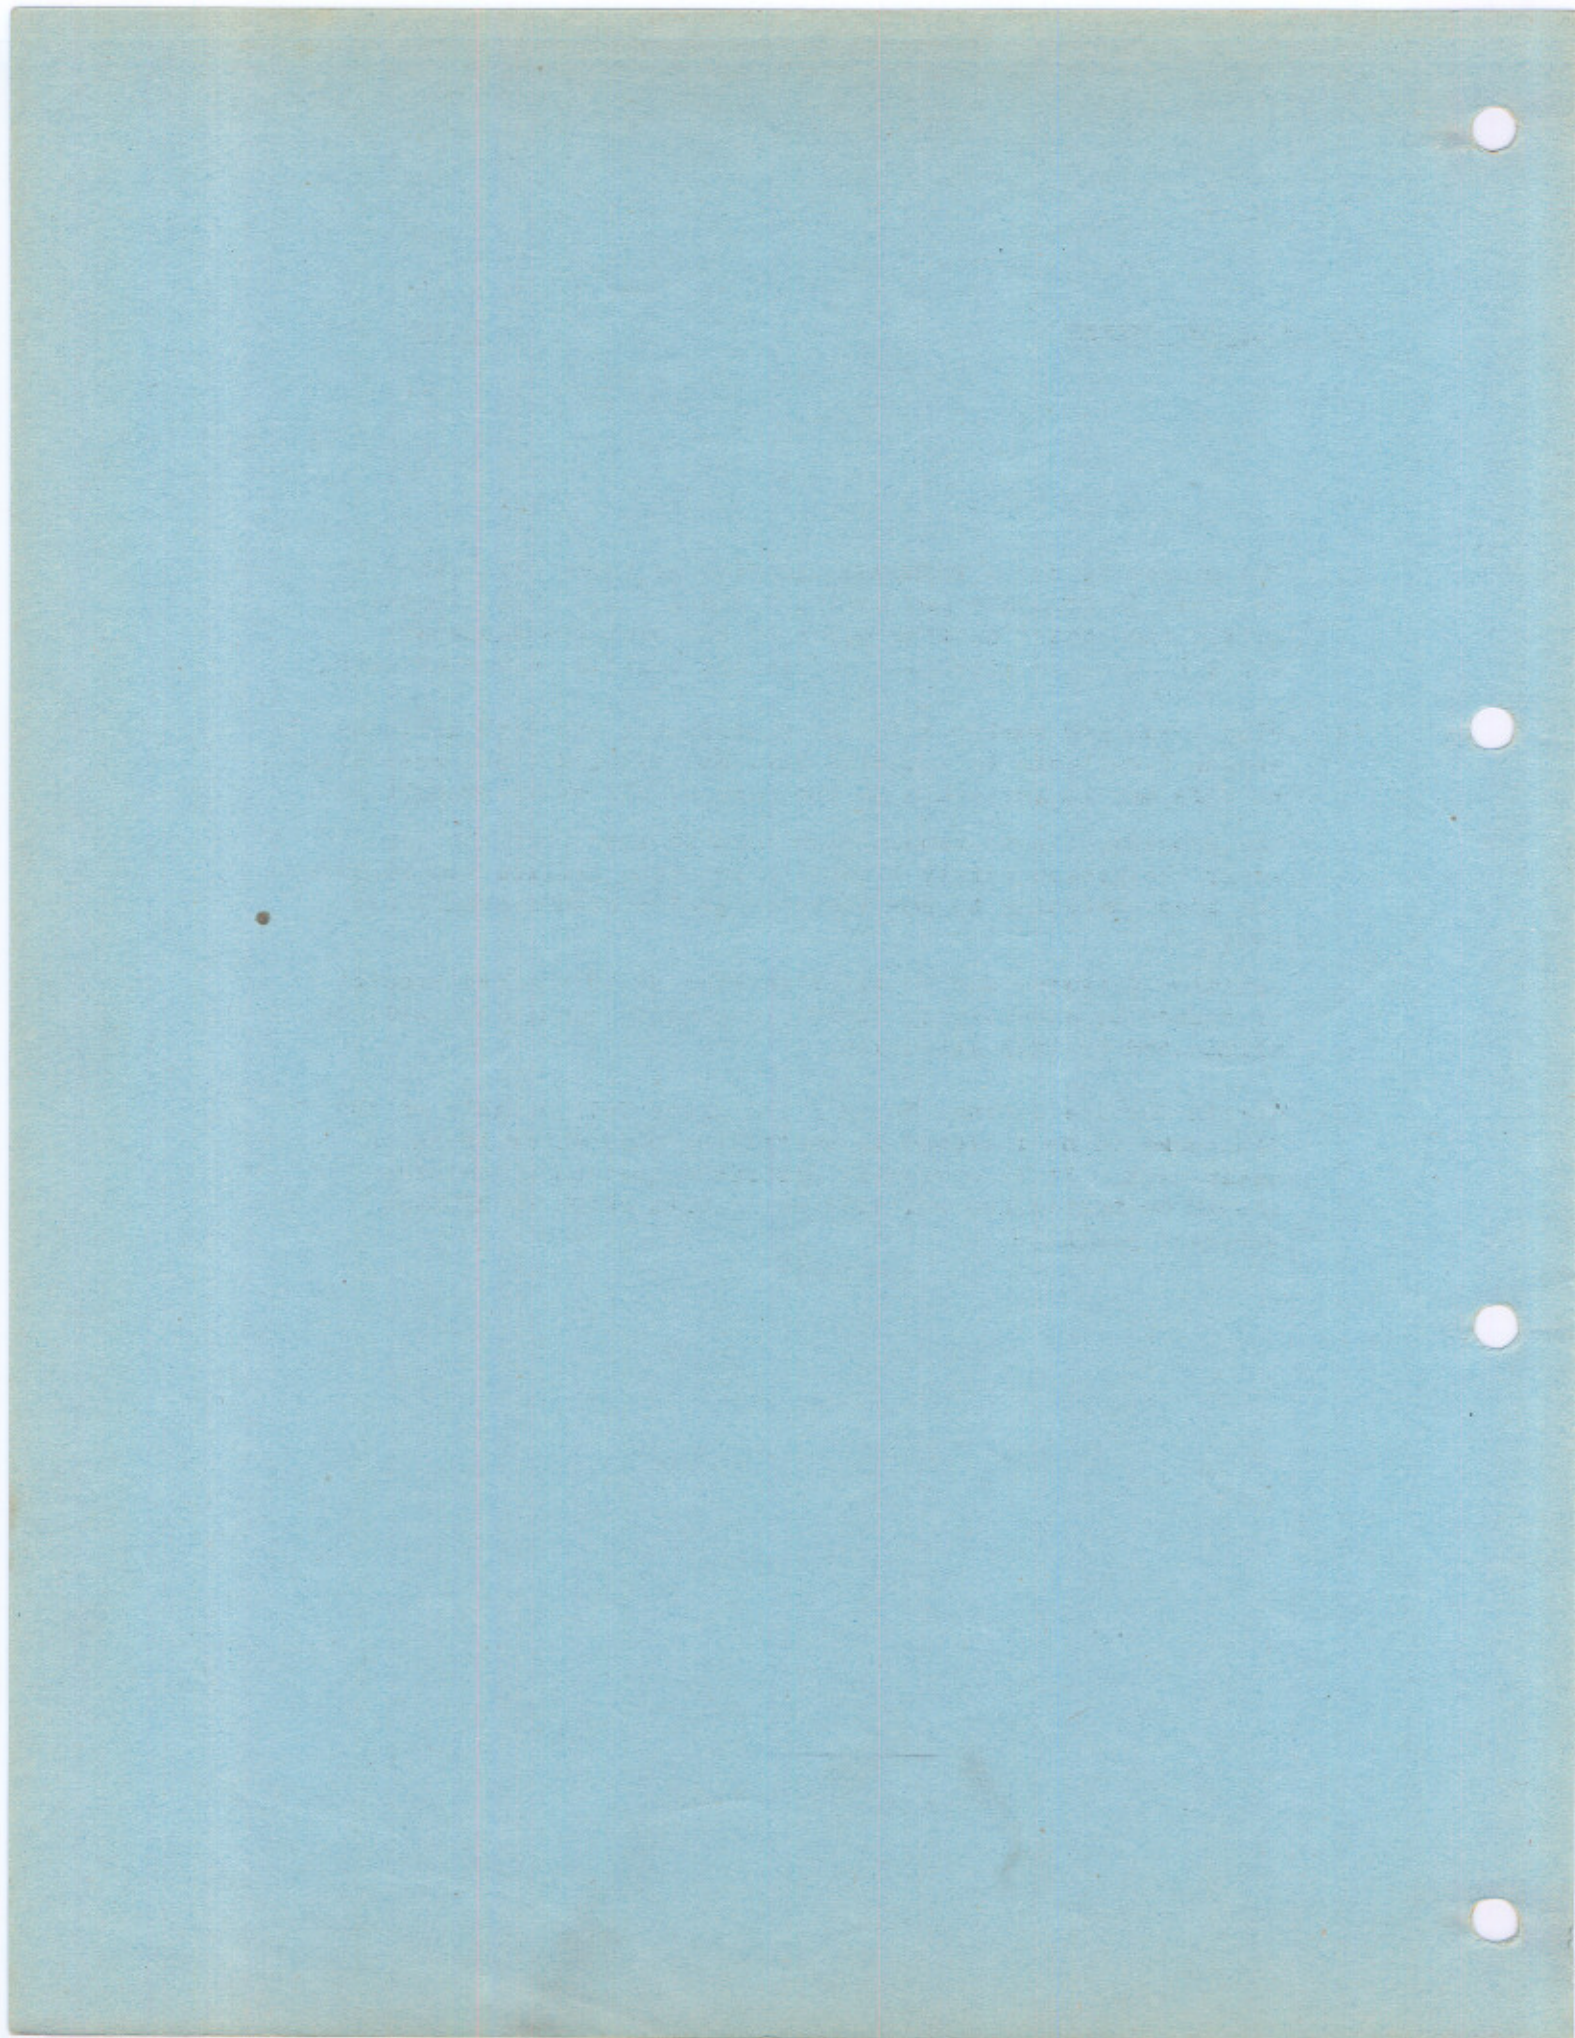
## OIL LEAKAGE INTO CLUTCH

There are three possible causes:

- (1) leakage past brass plug 'A' at end of oilway 'B'
- (2) leakage past seal 'C'
- (3) leakage past seal 'D'.

To check for (1), withdraw flywheel retaining screw 'E'. If this is quite dry, the brass plug 'A' is not suspect and dismantling should proceed in order that seals 'C' and 'D' may be examined. Leakage here would most likely be due to damage in assembly and new parts should be fitted as necessary.

If, on the other hand, oil leakage is in evidence at (1), this may be due to the fact that the rubber plug 'F' (Part No. 22A64) - which is an added precaution against leakage at the brass plug 'A' - is not in contact with the tip of the retaining screw 'E', as intended, and has therefore not been 'spread' and is failing to act as a seal.

In all cases of oil leakage into the clutch, the clutch friction surfaces should be examined and thoroughly cleaned, the driven plate being replaced if more than slightly contaminated.

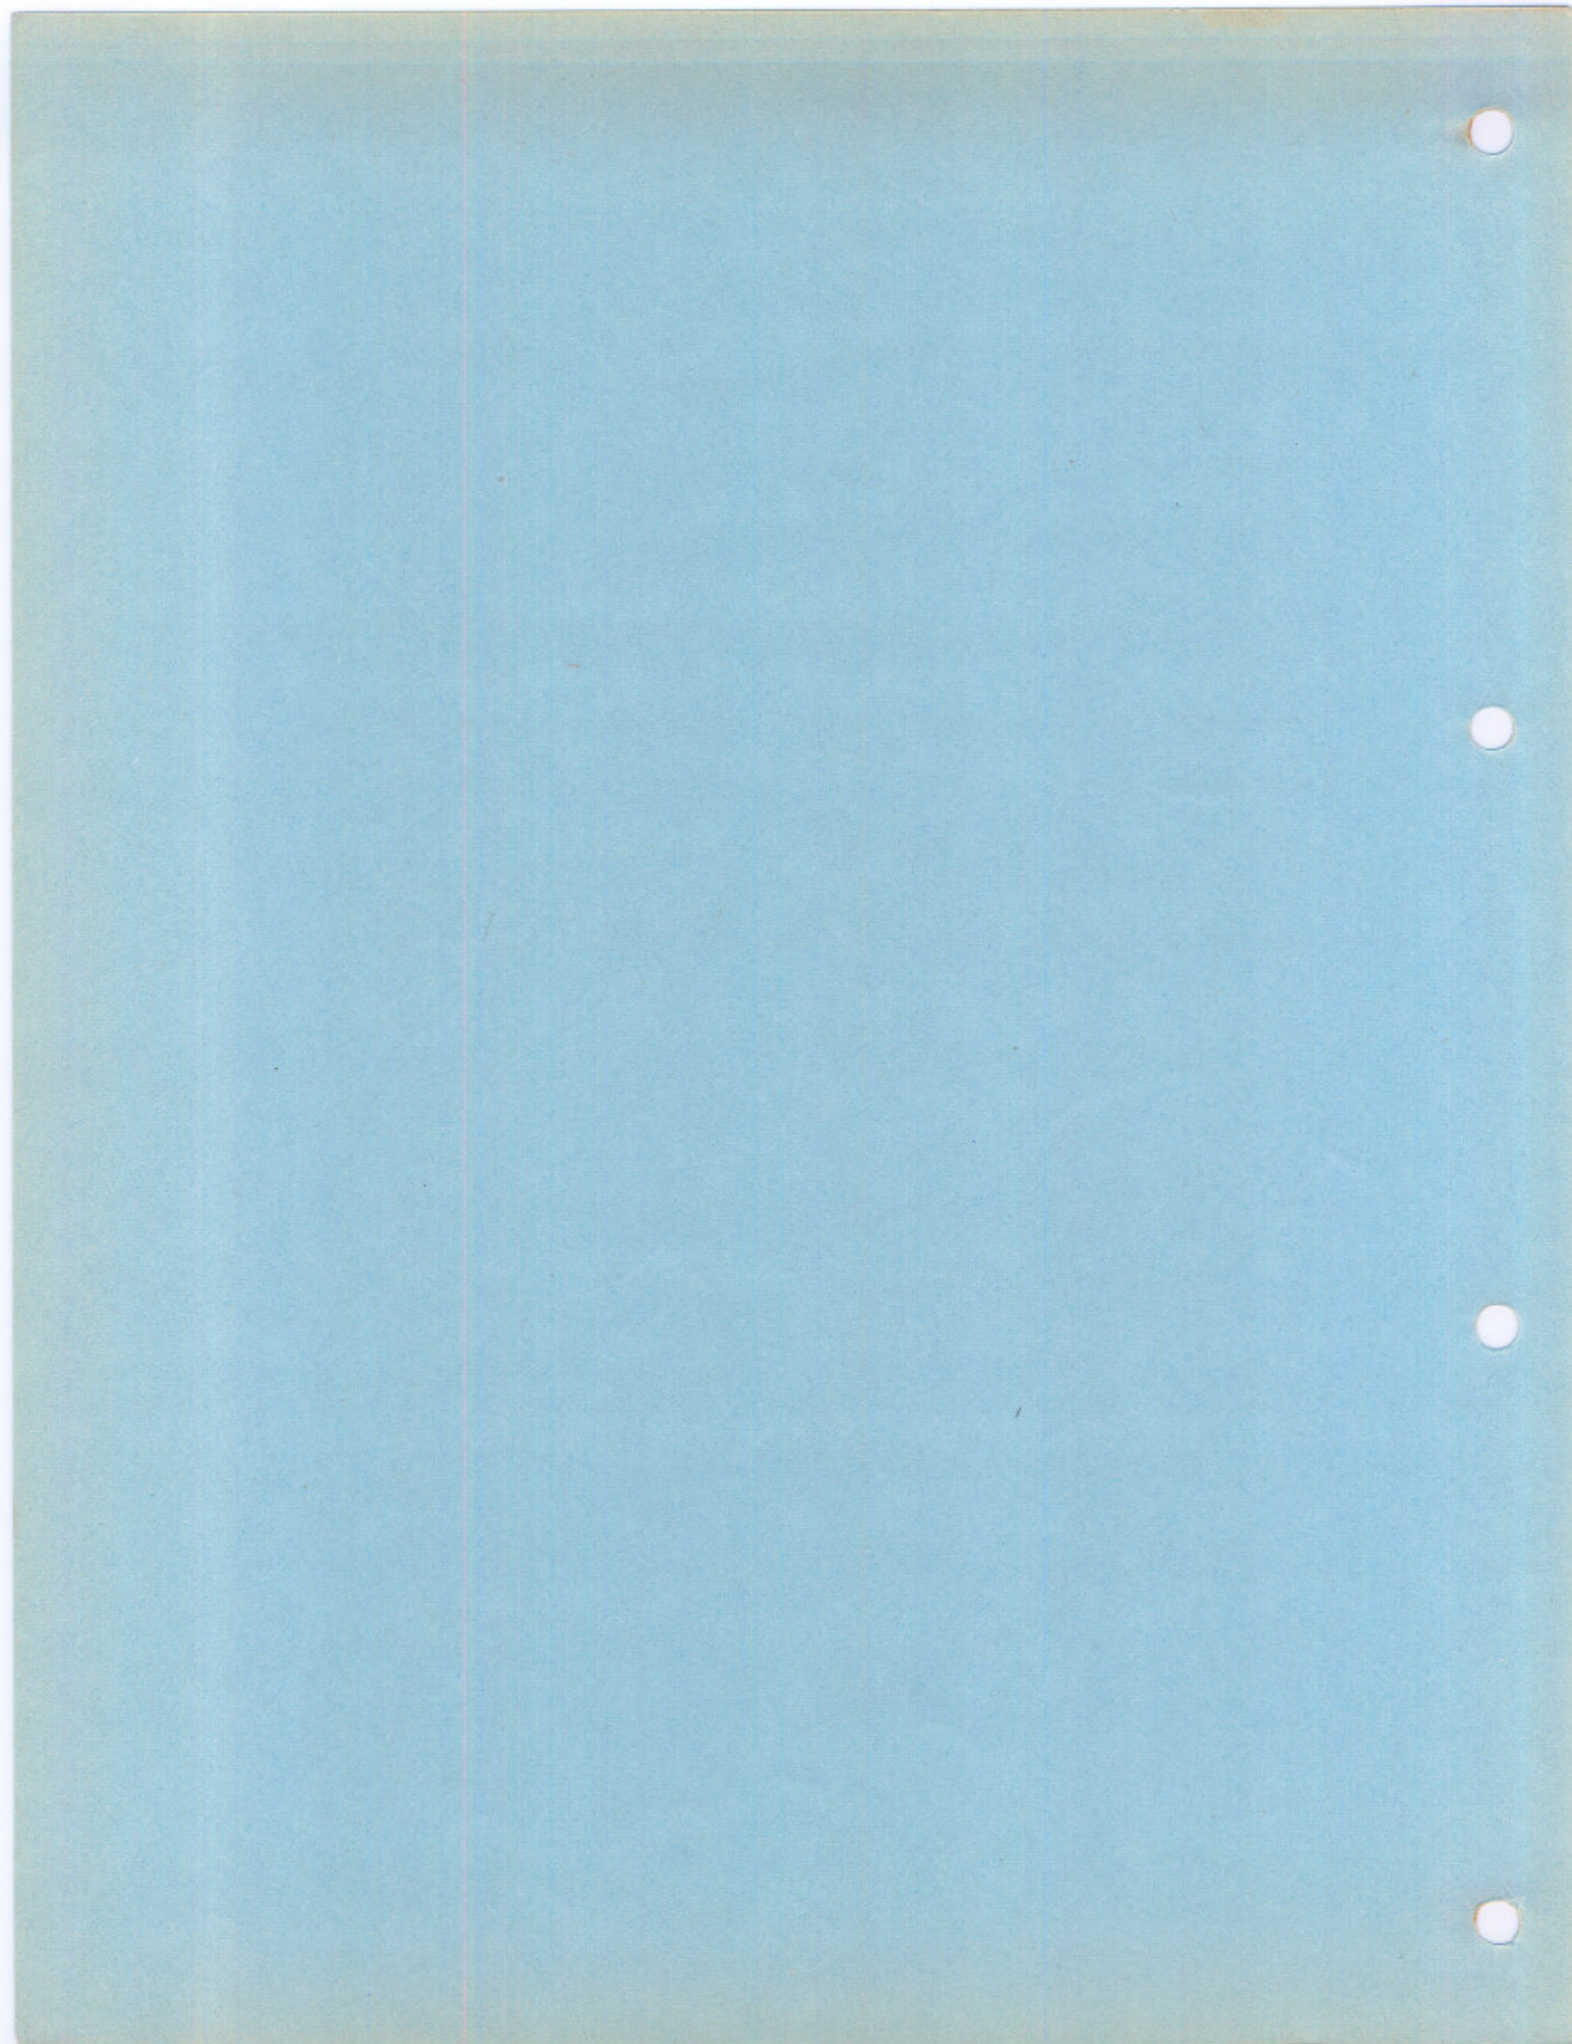
## CHOKE CONTROL CABLE

2. A tendency exists for the choke cable rubber grommet, protecting the cable casing in the dash panel, to be pulled out of position during marked engine vibration, thereby causing damage to the cable. This can be remedied by replacing the existing grommet with a rubber sleeve to allow for backward and forward "slide".

To achieve this modification, disconnect the choke cable at the carburetter and withdraw the cable from the bracket. Remove the existing rubber grommet from the cable and replace with the new rubber sleeve 'A' (Part No. 21A227) which should be positioned in the dash panel 'B' (Fig. 2) as illustrated. Re-connect the cable at the carburetter.

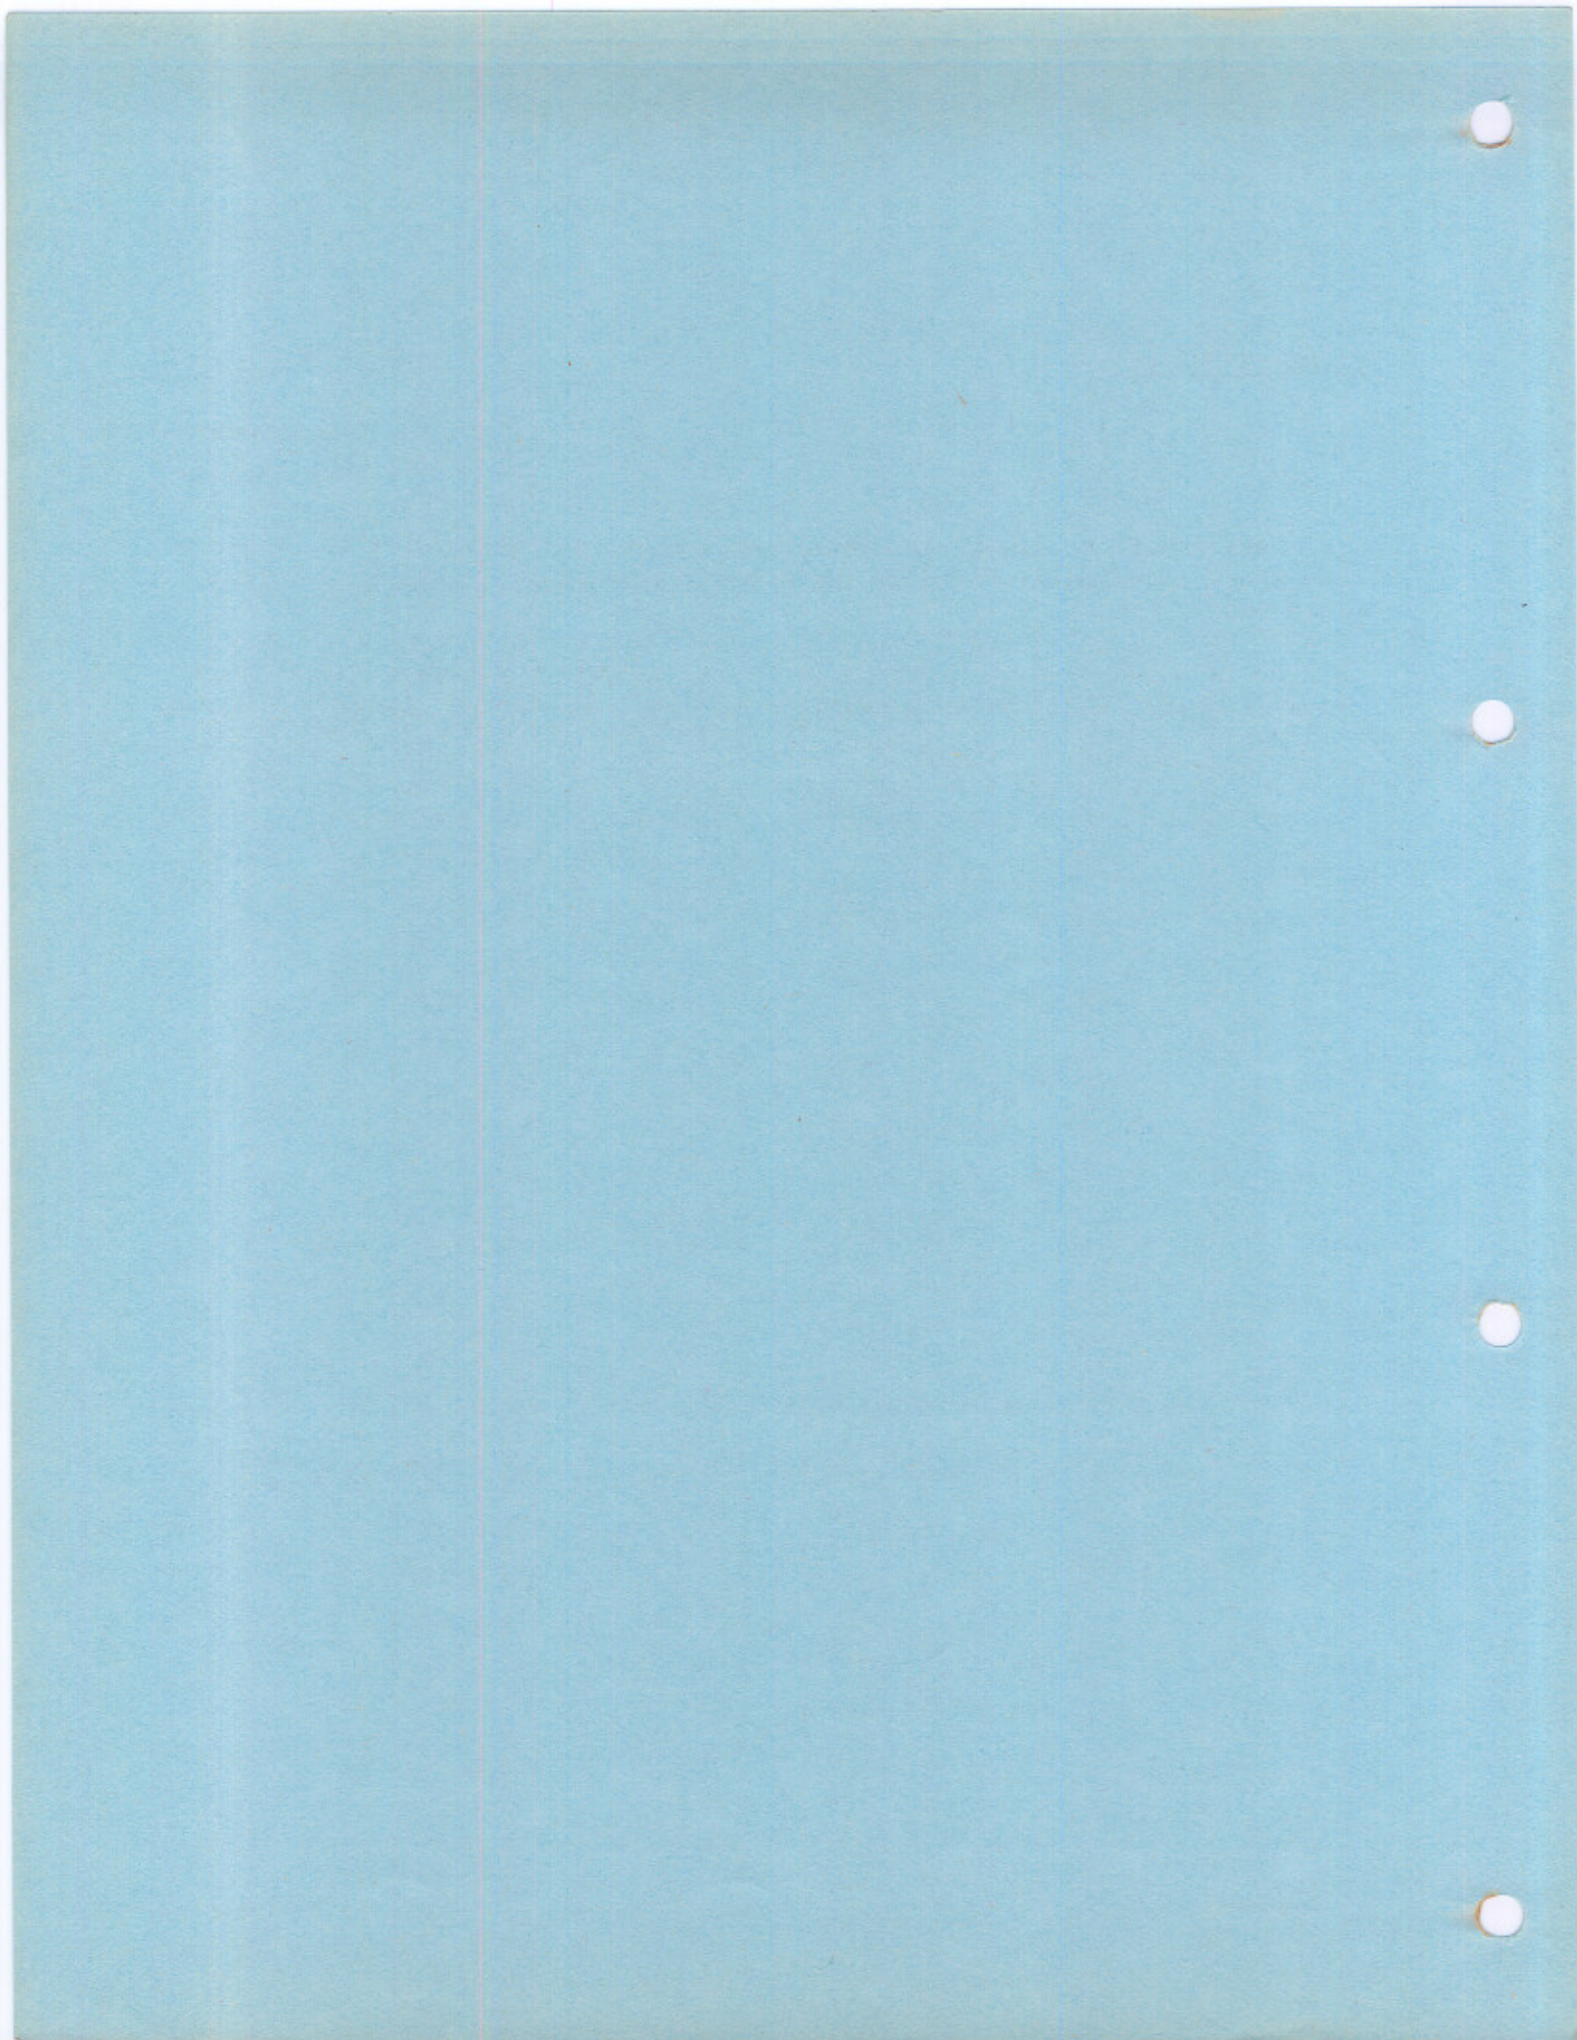
A / 171  
No. ....

## OIL LEAKAGE INTO CLUTCH

There are three possible causes:

- (1) leakage past brass plug 'A' at end of oilway 'B'
- (2) leakage past seal 'C'
- (3) leakage past seal 'D'

To check for (1), withdraw flywheel retaining screw 'E'. If this is quite dry, the brass plug 'A' is not suspect and dismantling should proceed in order that seal 'D' may be examined. Leakage here would most likely be due to damage in assembly and a new seal should be fitted if necessary. Leakage at 'C' will be prevented by a new type seal, Part No. 13H435, which has a steel outer shell.

If, on the other hand, oil leakage is in evidence at (1), this may be due to the fact that the rubber plug 'F' (Part No. 22A64) - which is an added precaution against leakage at the brass plug 'A' - is not in contact with the tip of the retaining screw 'E', as intended, and has therefore not been 'spread' and is failing to act as a seal.

In all cases of oil leakage into the clutch, the clutch friction surfaces should be examined and thoroughly cleaned, the driven plate being replaced if more than slightly contaminated.
