Distributor & Dealer  
Organization

26 January 1960

## PETROL TANK

SEVEN

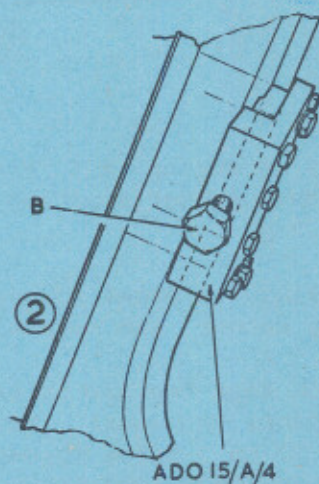
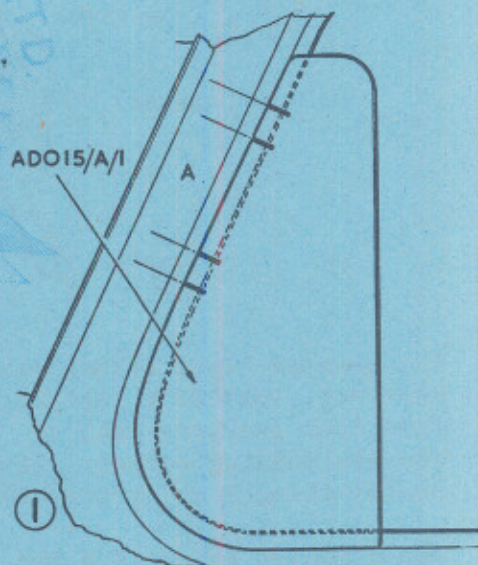
Commencing at Body No. 4046, an additional bracket, Part No. 14A7775, was introduced to improve the stability of the quarter-light catch operation. All bodies prior to this number should be modified as detailed below:

- (1) Remove the two screws securing hinged quarter-light catch to body panel, and fold back quarter-light against front door.
- (2) Remove quarter-light rubber seal.
- (3) Bend back trim towards back-light (great care must be taken not to crease material). This will reveal existing catch bracket, which need not be disturbed.
- (4) Position template ADO.15/A/1 on panel 'A' as shown in Fig.1; then with a pencil continue lines from slots in template on to outside of panel.
